Assessment of Lake Gaston Hydrilla Management Efforts in 2005

A Final Report to the Lake Gaston Weed Control Council

GeoResources Institute Report 5001
December 19, 2005

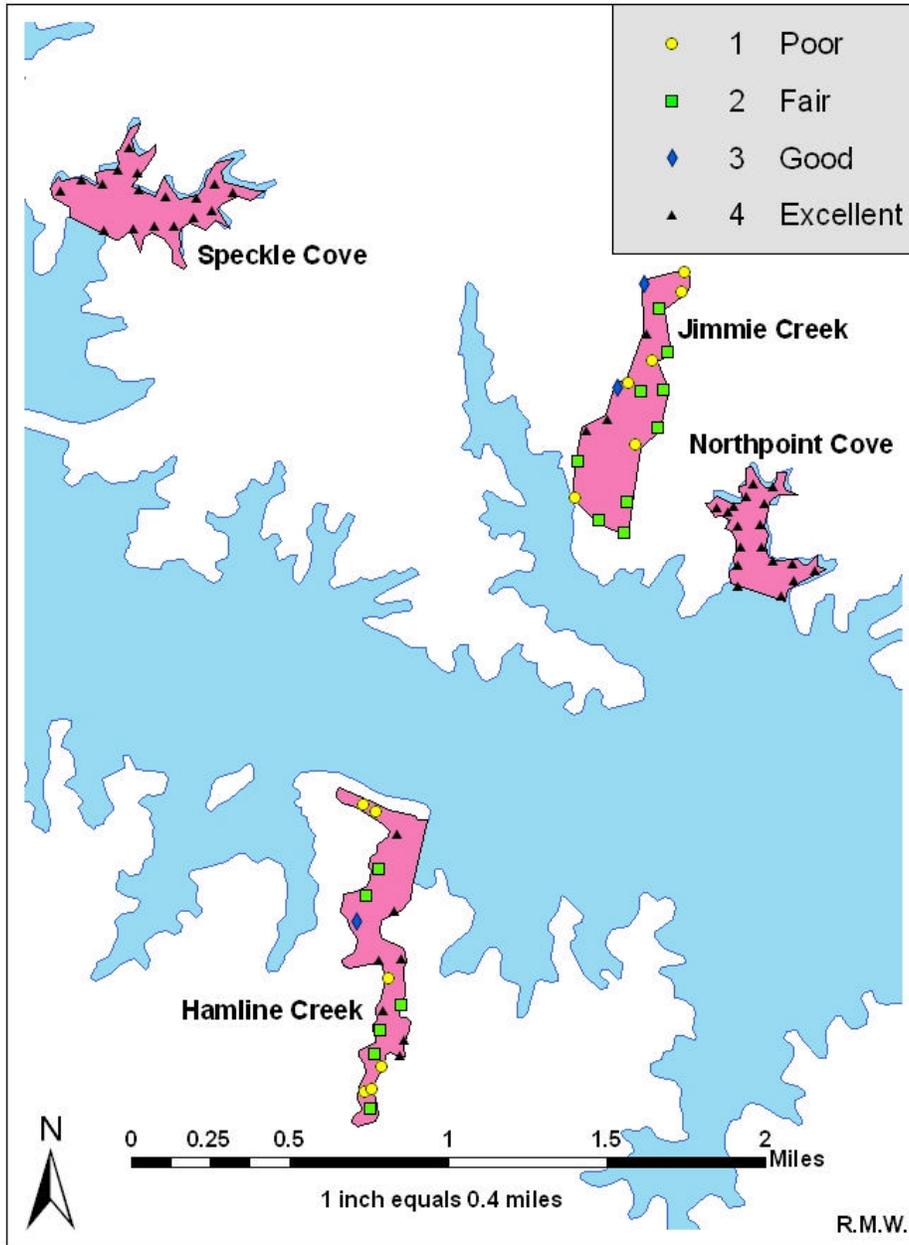
Northpoint Cove (7). Northpoint Cove was treated with fluridone in 2005 (Figure 2). The treatment was excellent, with hydrilla found at 45% of points (Figure 6), but an average rating of 4 (Figure 7). None of the points had topped-out hydrilla (Figure 8). Species diversity was a little lower than the average for all sites (Figures 9, 10). The marginal vegetation was waterwillow (Table 2), and other species observed at points was chara, lyngbya, and leafy pondweed (Table 3).

Speckle Cove (9). Speckle Cove was treated with fluridone in 2005 (Figure 2). The treatment was excellent, with no hydrilla observed at any points (Figure 6), and an average rating of 4 (Figure 7). No topped-out hydrilla was observed (Figure 8). Species diversity was a little lower than the average for all sites (Figures 9, 10). Waterwillow was the only marginal vegetation species (Table 2), and chara and waterwillow were observed at points (Table 3).

Jimmie Creek (11). Jimmie Creek was treated with fluridone in 2004 (Figure 2). All of the points in Jimmie Creek had hydrilla (Figure 6). Jimmie Creek, which had a rating of 4 in 2004, had a rating of 2.1 in 2005, indicating extensive regrowth (Figure 7). Topped out hydrilla was observed in 63% of points (Figure 8). No native species were observed at any points in Jimmie Creek (Figure 10, Table 3). Waterwillow and lyngbya were also observed (Tables 2, 3).

Hamline Creek (15). Hamline Creek has never been treated with fluridone for hydrilla, and may be considered a baseline of what an area would look like without treatments (Figure 2). Hydrilla was found at 90% of points (Figure 6), and the rating was 2.4 (fair; Figure 7). Hydrilla was topped-out at 35% of points (Figure 8). Diversity of native species was extremely low (Figure 10). Waterwillow and lyngbya were the only other plants observed (Tables 2, 3).

Figure 2. Map of assessment sites Hamline Creek (15), Jimmie Creek (11), Northpoint Cove (7), and Speckle Cove (9) in Lake Gaston. Symbol shape and color indicate efficacy rating (see legend).

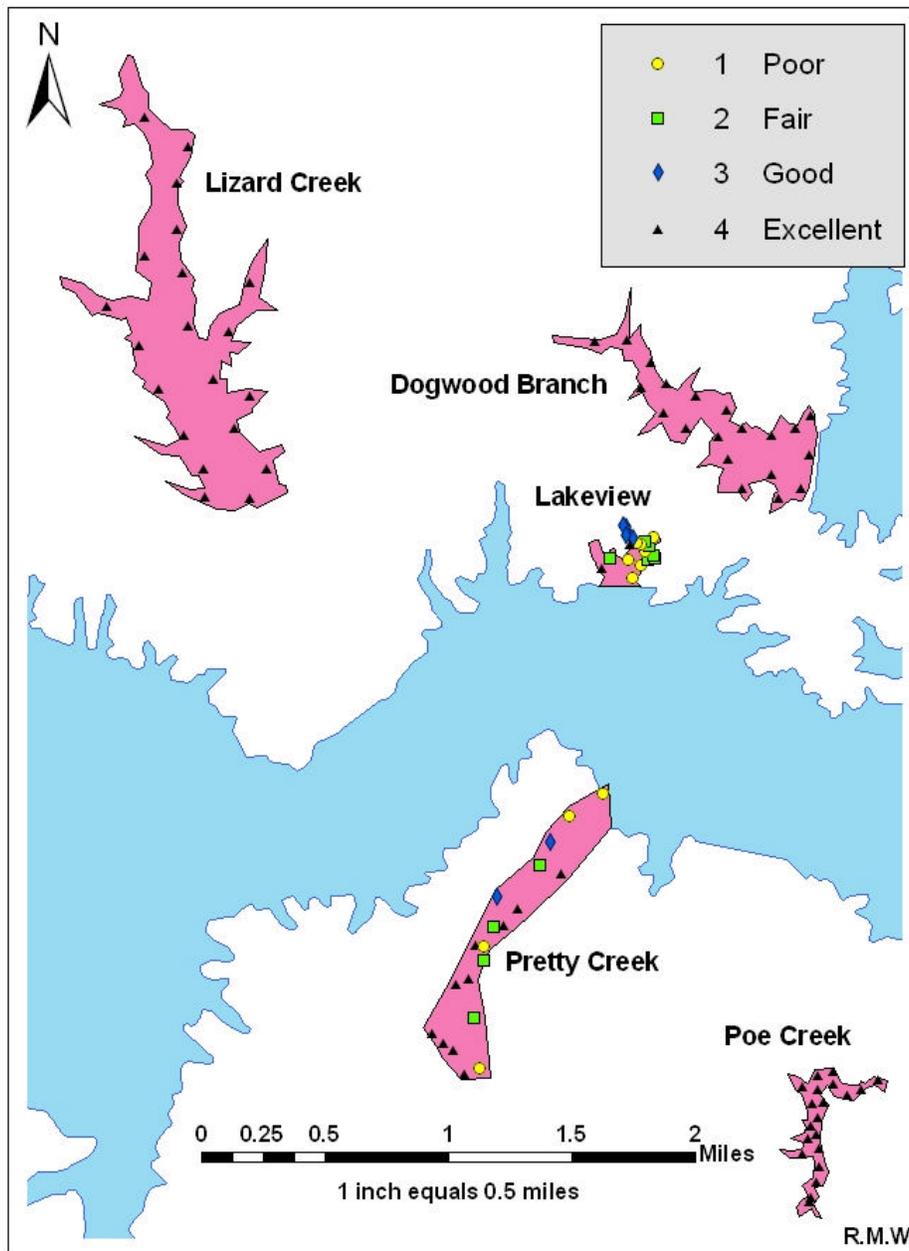
Dogwood Branch (1). Dogwood Branch was treated with fluridone in 2005. Dogwood Branch (Figure 3) was a successful treatment, with an average rating of 4 (Figure 7). No hydrilla was observed at any point (Figure 6), nor was any topped-out hydrilla observed (Figure 8). Species diversity was average for the sites examined (Figure 9), though native species diversity was high for the sites assessed (Figure 10). Dogwood Branch had waterwillow as marginal vegetation (Table 2), and also had Chara and Lyngbya (Table 3).

Lizard Creek (5). Lizard Creek was treated with fluridone in 2005 (Figure 3). The Lizard Creek treatment was excellent, with no points having hydrilla (Figure 6), and an average rating of 4 (Figure 7). No points had topped-out hydrilla (Figure 8). No marginal vegetation was observed (Table 2), and chara was the only species observed (Table 3). Grass carp feeding was observed at this site (Table 4). However, species diversity at this site was very low (Figures 9, 10).

Poe Creek (8). Poe Creek was treated with fluridone in 2005 (Figure 3). The treatment was excellent, with 20% of points with hydrilla (Figure 6), and an averaged rating of 4 (Figure 7). No points had topped-out hydrilla (Figure 8). Species diversity was a little lower than the average for all sites (Figures 9, 10). No marginal species were observed (Table 2), and other species observed at points were chara, lyngbya, and southern naiad (Table 3). Evidence of grass carp feeding was observed (Table 4).

Pretty Creek (13). Pretty Creek was treated with fluridone in 2003 (Figure 3). Hydrilla was observed at 85% of points (Figure 6), and topped out at 40% of points (Figure 8). The average rating for this site was 2.9, which is less than good (Figure 7). No native species were observed (Figure 10). Waterwillow, and lyngbya were also observed (Tables 2, 3). Reinvasion by hydrilla is well underway.

Lakeview (16). Lakeview was the second site that was assessed that has never been treated with fluridone for hydrilla (Figure 3). Hydrilla was found at all points (Figure 6), and rating was 2.1 (fair, Figure 7). Topped out hydrilla was found at 60% of the points (Figure 8). No native species were found at any points (Figure 10, Table 3). Waterwillow was the only marginal plant species (Table 2).

Figure 3. Assessment sites Dogwood Branch (1), Lakeview (16), Lizard Creek (5), Poe Creek (8), and Pretty Creek (13) in Lake Gaston. Symbol shape and color indicate efficacy rating (see legend).

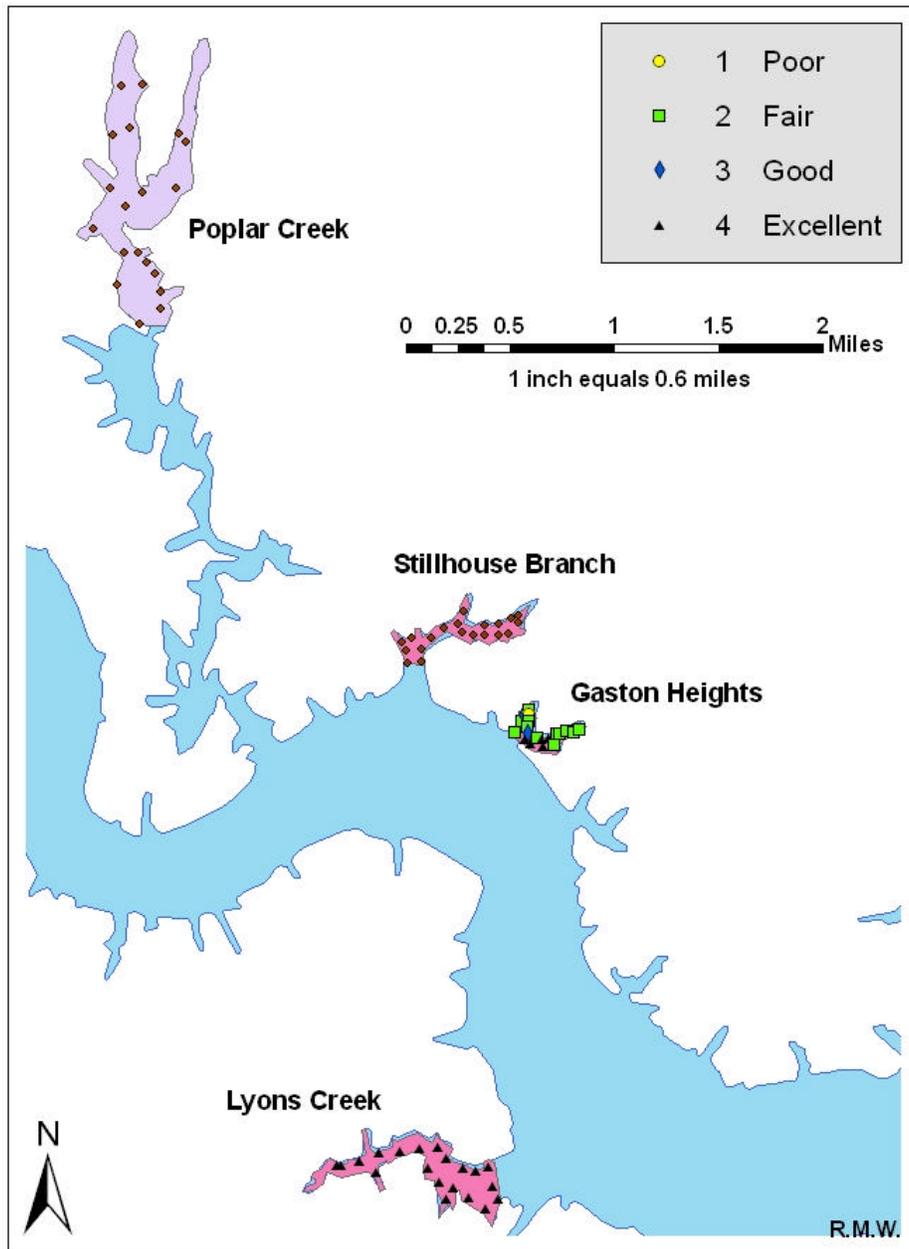
Gaston Heights (3). Gaston Heights was treated with fluridone in 2005, but only three weeks before assessment (Figure 4). Hydrilla was found in 100% of the points, but the hydrilla was beginning to die by this time (Figure 6). Treatment rating averaged 2.5, which is between fair and good (Figure 7). Hydrilla was topped out at 70% of the points. Native plant diversity was poor at this site (Figure 10). Marginal vegetation included waterwillow and giant cutgrass (Table 2). The only other species observed was coontail (Table 3).

Lyons Creek (6). Lyons Creek was treated with fluridone in 2005 (Figure 4). The treatment had excellent results, with only 10% of points having hydrilla (Figure 6), and an average rating of 4 (Figure 7). No topped out hydrilla was observed (Figure 8). However, species diversity at this site was very low (Figures 9, 10). Marginal vegetation included waterwillow, American lotus, and pickerelweed (Table 2). Other species at points included American lotus (Table 3).

Stillhouse Branch (10). Stillhouse Branch is the last of the sites treated in 2005, and the treatment occurred only three weeks before the assessment (Figure 4). Due to this late treatment, hydrilla was still found at 80% of points (Figure 6), and the rating was only 3.2 (Figure 7). Topped-out hydrilla was found at 32% of points (Figure 8). The fluridone exposure time was not yet sufficient for complete control, but plants were showing definite symptoms and were beginning to senesce. While average number of species was relatively high (Figure 9), none of these were native species (Figure 10). Waterwillow was the only marginal species (Table 2), and Lyngbya the only species observed other than hydrilla (Table 3). Grass carp feeding was observed at this site (Table 4).

Poplar Creek (12). Poplar Creek was treated with fluridone in 2003 and 2004 (Figure 4). Only 40% of points had hydrilla (Figure 6), and the rating for this site was just short of 4 (Figure 7). No topped out hydrilla was observed (Figure 8). Native species diversity was observed at this site (Figure 10). Waterwillow and brittle naiad were also observed (Tables 2, 3). This site demonstrates that two successive years of treatment with fluridone may slow the reestablishment rate from tubers in large creeks.

Figure 4. Assessment sites Gaston Heights (3), Lyons Creek (6), Poplar Creek (12), and Stillhouse Branch (10) in Lake Gaston. Symbol shape and color indicate efficacy rating (see legend).

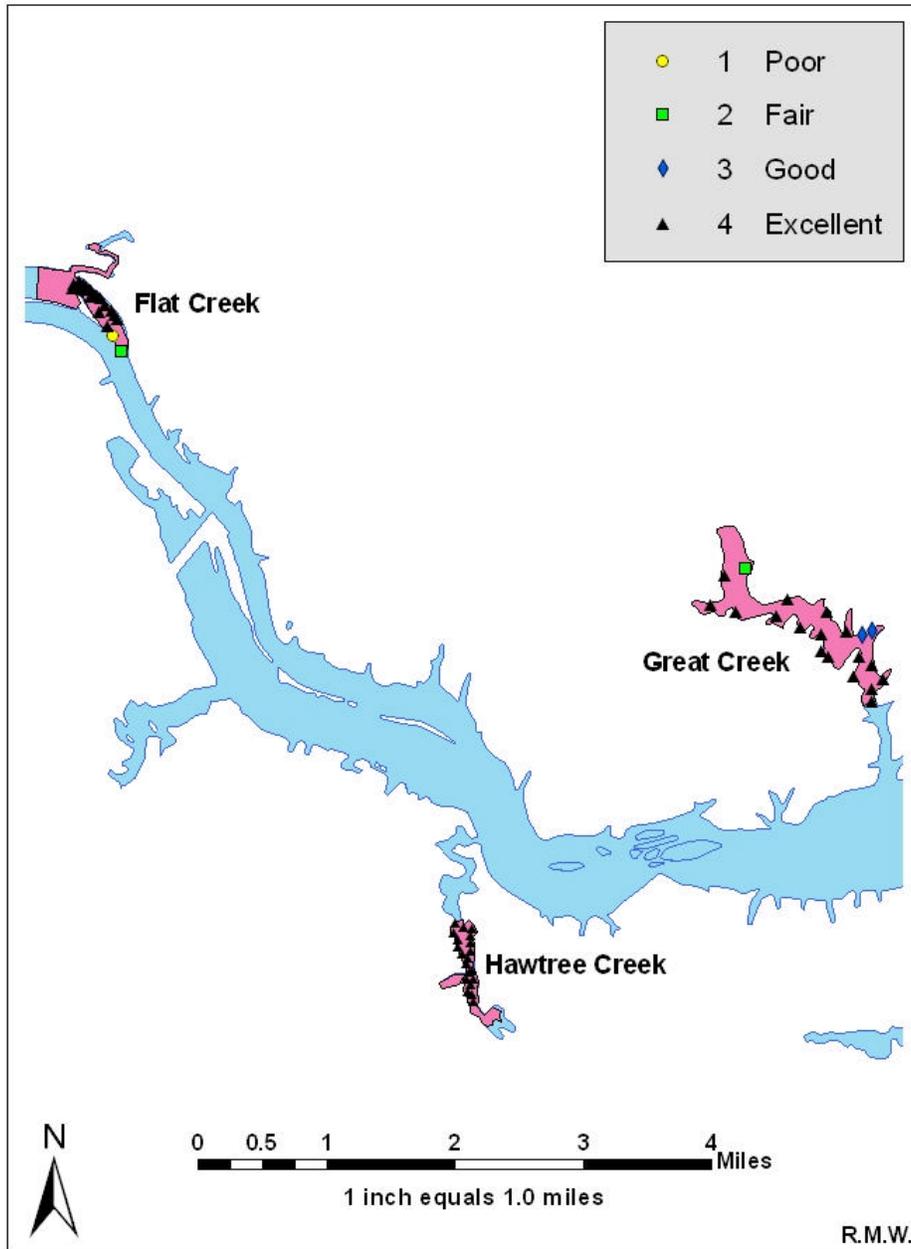
Flat Creek (2). Flat Creek was treated with fluridone in 2005. Flat Creek (Figure 5) was a successful treatment, with 30% of points having hydrilla (Figure 6) and an average rating of 3.8 (Figure 7). Only 5% of points had topped-out hydrilla (Figure 8). Average species diversity (Figure 9) and average number of native species (Figure 10) were both high for the assessed sites. Marginal vegetation was cattail and pickerelweed (Table 2). Other plant species observed at Flat Creek were chara, coontail, and egeria (Table 3).

Hawtree Creek (4). Hawtree Creek was treated with fluridone in 2005 (Figure 5). The Hawtree Creek treatment was excellent, with only 5% of points with hydrilla (Figure 6) and an average rating of 4 (Figure 7). No points had topped out hydrilla (Figure 8). Native species diversity, in terms of average number of native species per point, was the highest in the assessment (Figure 10). Hawtree Creek had all six species of marginal vegetation observed in the survey (Table 2), and American lotus and yellow pond lily were observed as well (Table 3).

Great Creek (14). Great Creek was treated with fluridone in 2000 (Figure 5). Hydrilla was observed in 30% of the points (Figure 6), and the rating averaged 3.8 (Figure 7). Hydrilla was topped-out at only 10% of points (Figure 8). Species diversity was low (Figure 9, 10). Waterwillow and cattail comprised the marginal vegetation (Table 2). No submersed plants other than hydrilla was observed, but the water was unusually turbid, even for Lake Gaston (Table 3). The Great Creek treatment in 2000 has maintained good control of hydrilla for five years, though it may be advisable to treat the remaining hydrilla soon before it spreads.

Figure 5. Assessment sites Flat Creek (2), Great Creek (14), and Hawtree Creek (4) in Lake Gaston. Symbol shape and color indicate efficacy rating (see legend).

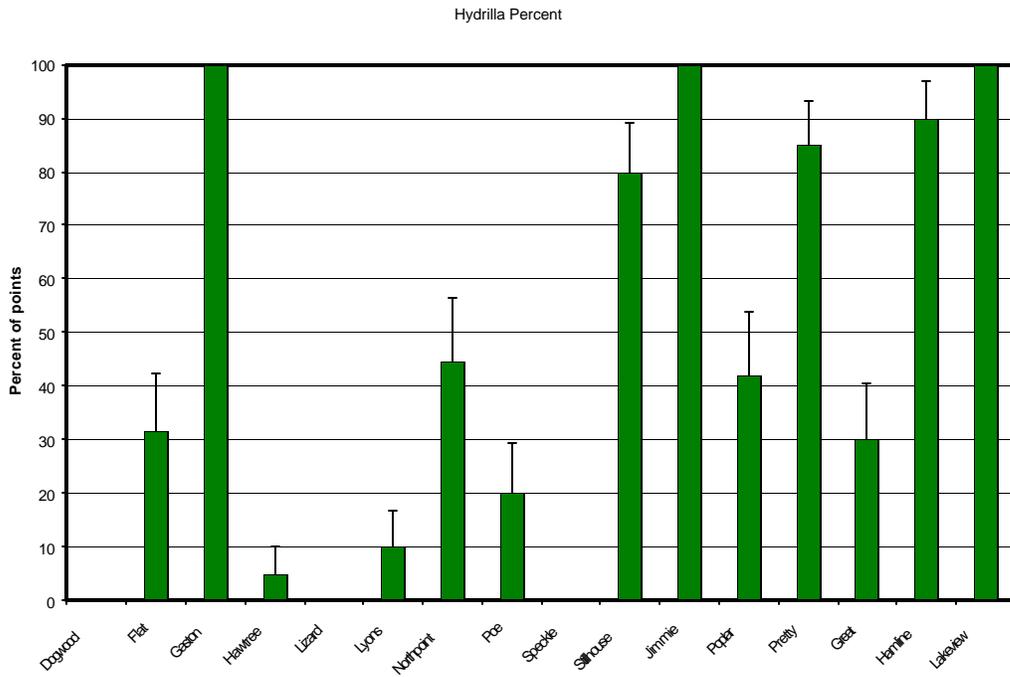
weeks prior to survey, treated sites had significantly less hydrilla (29.3%) than any of the other sites but the fluridone site treated in 2000, and the comparison to untreated sites (95% of points with hydrilla) is highly significant. Excluding those two sites (Gaston Heights and Stillhouse Branch), hydrilla percent frequency is 13%. Large-scale fluridone treatments can control large areas of hydrilla; often beyond the treatment zone, and in some instances the control can last for multiple years.

Figure 6. Hydrilla percent frequency at assessment sites.

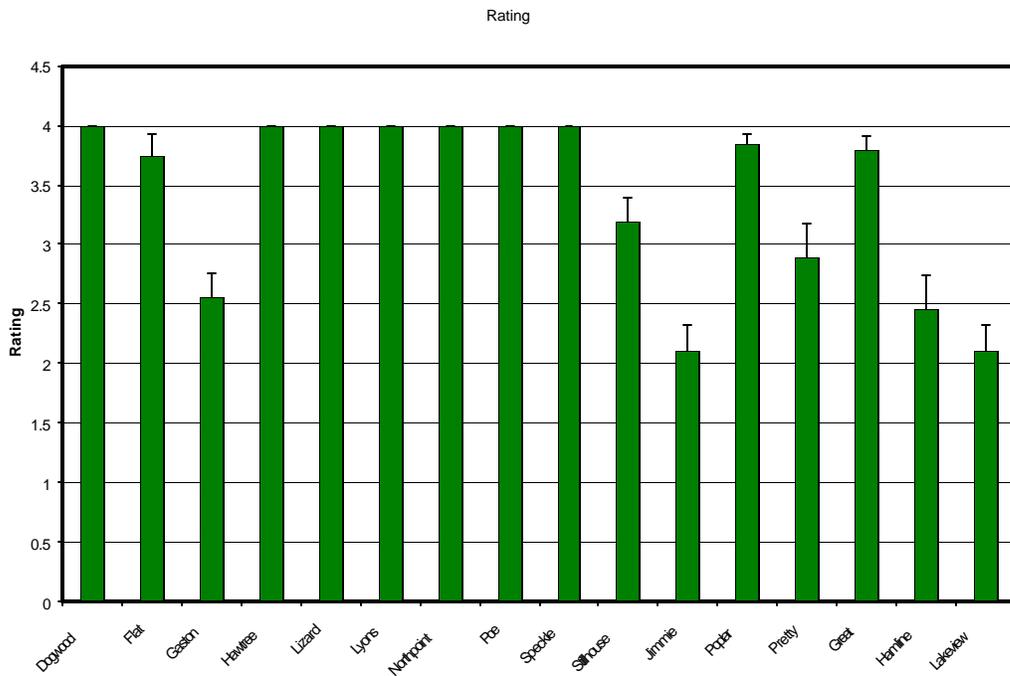
Success Rating and Nuisance Level. The average rating for all ten sites treated in 2005 was 3.7, which is significantly higher than all other years other than the treatment in year 2000 (Table 6). If the two recently treated sites are excluded, this average increased to 3.97. Fluridone treatments can control hydrilla over a wide area, and give excellent relief from nuisance growth. Nuisance growth, measured by the frequency of topped-out hydrilla, also was lowest in the sites treated with fluridone in 2005. Only 11% of points had topped-out hydrilla in the sites treated in 2005, as compared to 40% of sites treated in 2003 and 47.5% of points in the untreated sites (Table 7). If the two recently treated sites are omitted, the remaining eight sites averaged 0.65% of the points having topped-out hydrilla – a near-complete removal of the nuisance problem.

Figure 7. Treatment rating for assessment sites in Lake Gaston. Rating scale given in Methods section.

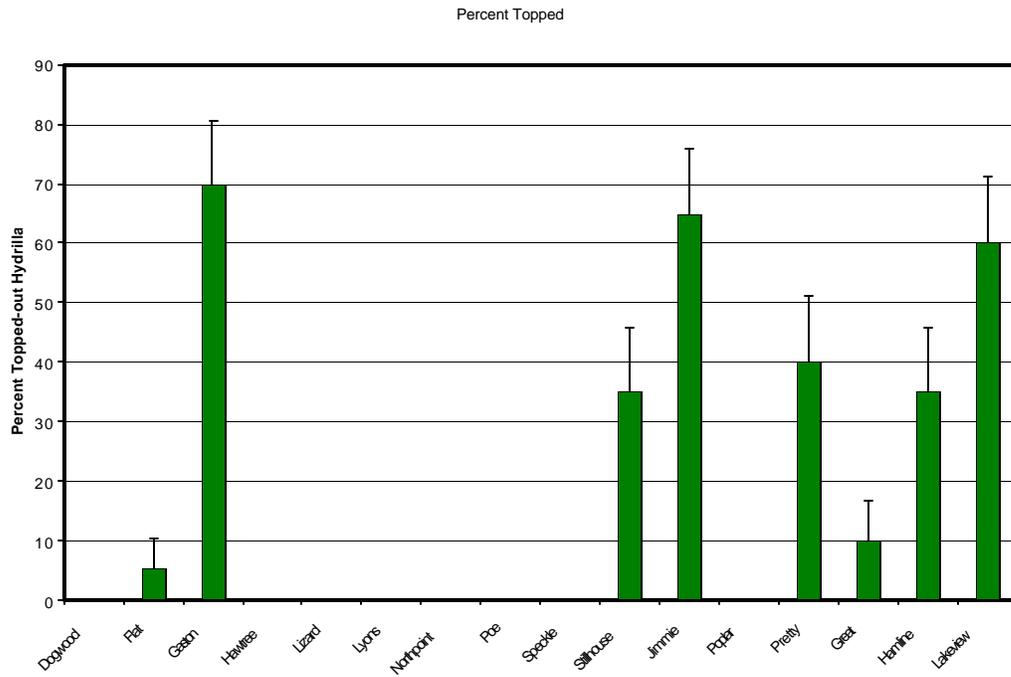
Figure 8. Percent frequency of points with topped-out hydrilla at each assessment site in Lake Gaston.

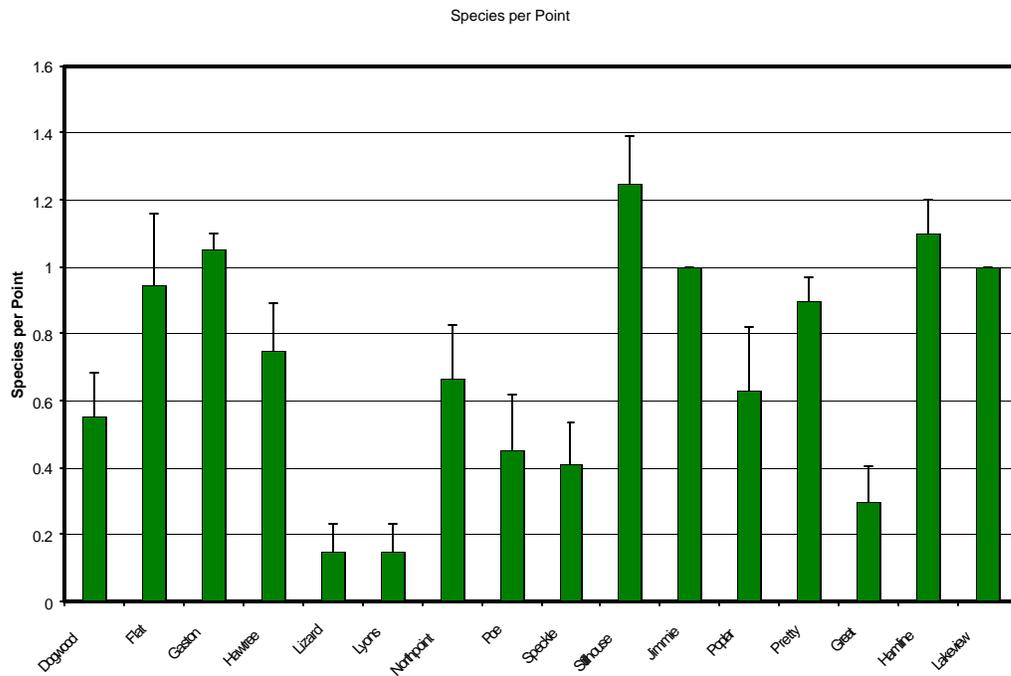
Figure 9. Average number of species per point in the assessment sites in Lake Gaston.

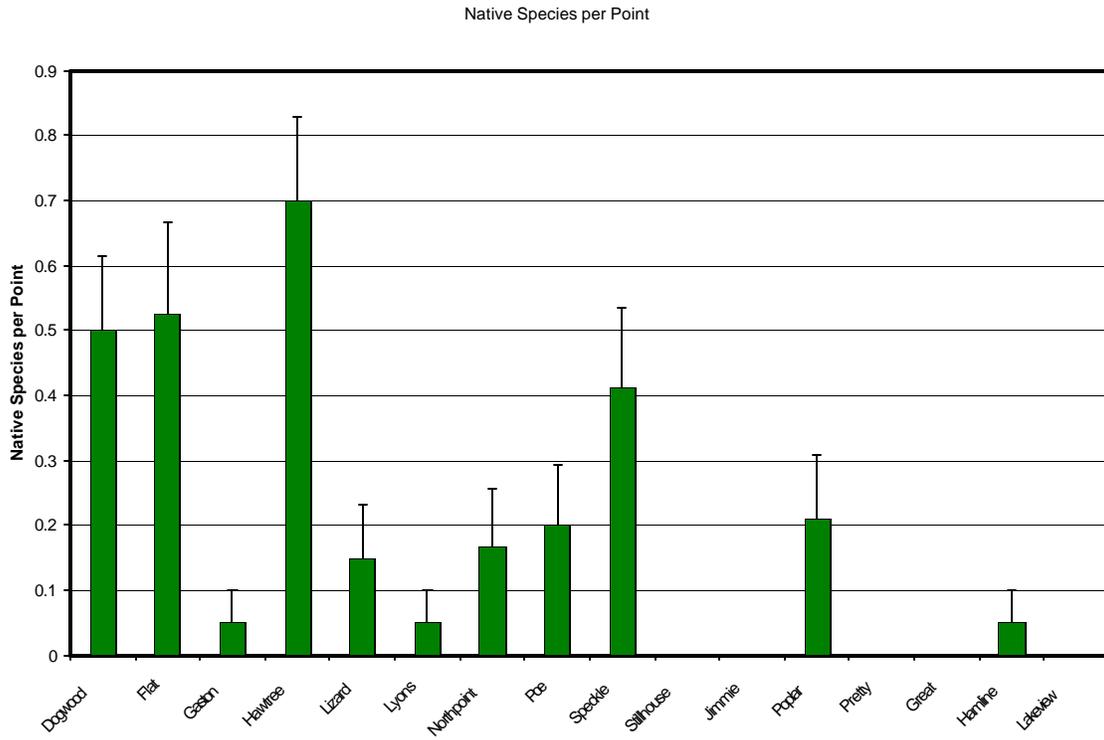
Species Diversity. Although native plant diversity is low in all sites, the recently treated sites (2005) have significantly more native species per point than all other years (Table 8). Although fluridone treatment may well cause mortality of some native plants, the competitive exclusion of natives by hydrilla is apparently more of a problem to native species.

Figure 10. Average number of native species per point at assessment sites in Lake Gaston.
