Lake Havasu Aquatic Plant Monitoring 2011 Interim Report

An Interim Report Submitted to RNT Consulting and the Central Arizona Project
John D. Madsen, Ryan M. Wersal, Amanda Fernandez and Gray Turnage
Geosystems Research Institute, Mississippi State University

GRI Report #4008

April 16, 2012

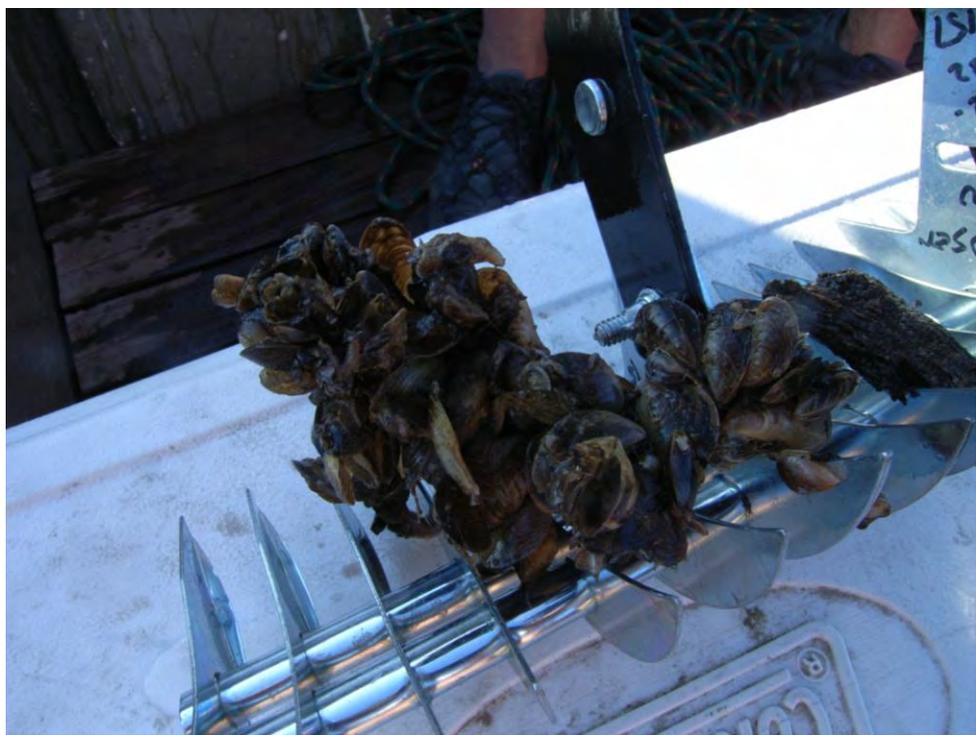
Figure 1. Quagga mussels (*Dreissena rostriformis bugensis*) collected from Lake Havasu in September 2011. Photo by John D. Madsen

For several decades, Lake Havasu on the Colorado River has been the source of a significant amount of water for the Central Arizona Project (CAP), and operated without significant nuisance vegetation problems. Over the past few years, there has been an increase in the amount of dead plant matter periodically floating into the intake and interrupting operations at the Mark Wilmer pumping plant. The origin of these problems was discussed in a previous report (Madsen 2011), but the most likely explanation is increased water transparency caused by the introduction and establishment of quagga mussels (*Dreissena rostriformis bugensis*) (Figure 1).

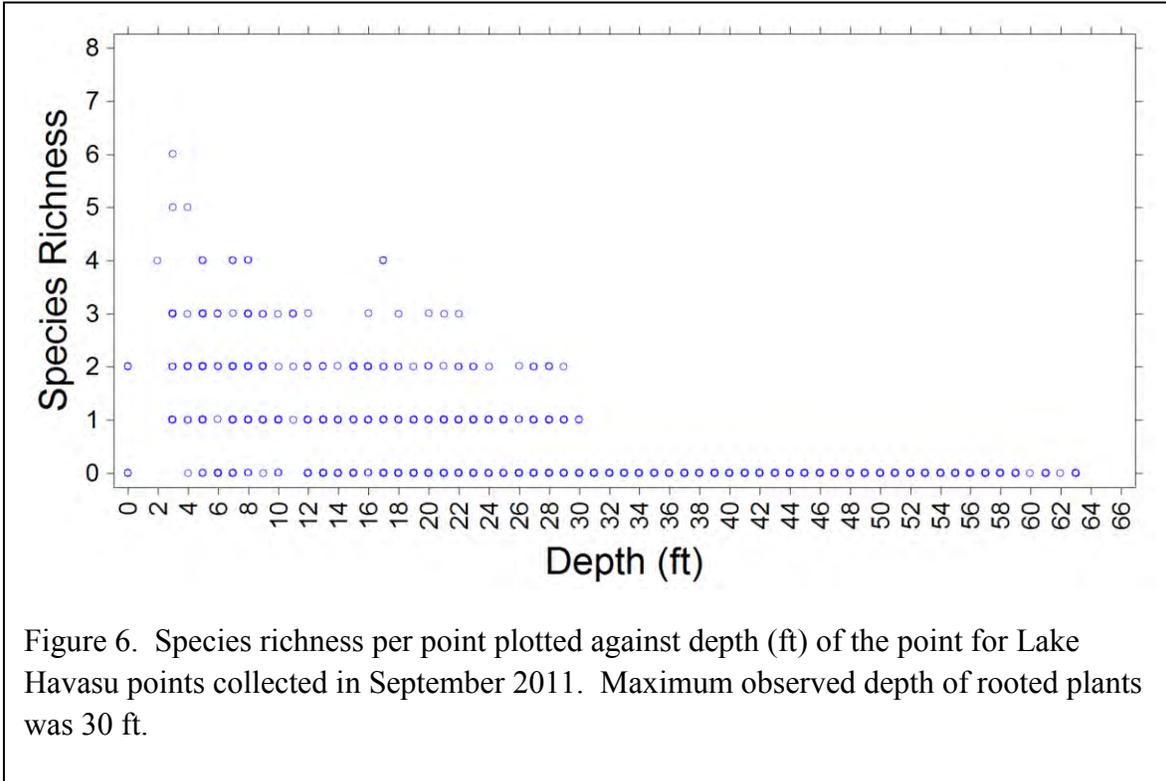
Figure 6. Species richness per point plotted against depth (ft) of the point for Lake Havasu points collected in September 2011. Maximum observed depth of rooted plants was 30 ft.

depth of survey points demonstrates that the maximum observed depth of colonization for aquatic plants was 30 ft (Figure 6). Subsequent analyses referring to the “littoral zone” or range to which rooted plants will survive refers to the area of the reservoir from 0 to 30 feet deep. Also notice that, as a general trend, aquatic plant diversity (richness) tends to decrease with water depth; the most diverse habitats are in waters from 2 to 4 feet deep. The littoral zone was represented as 680 of the 1623 points in the lake, or about 42% of the lake surface area (or bottom).

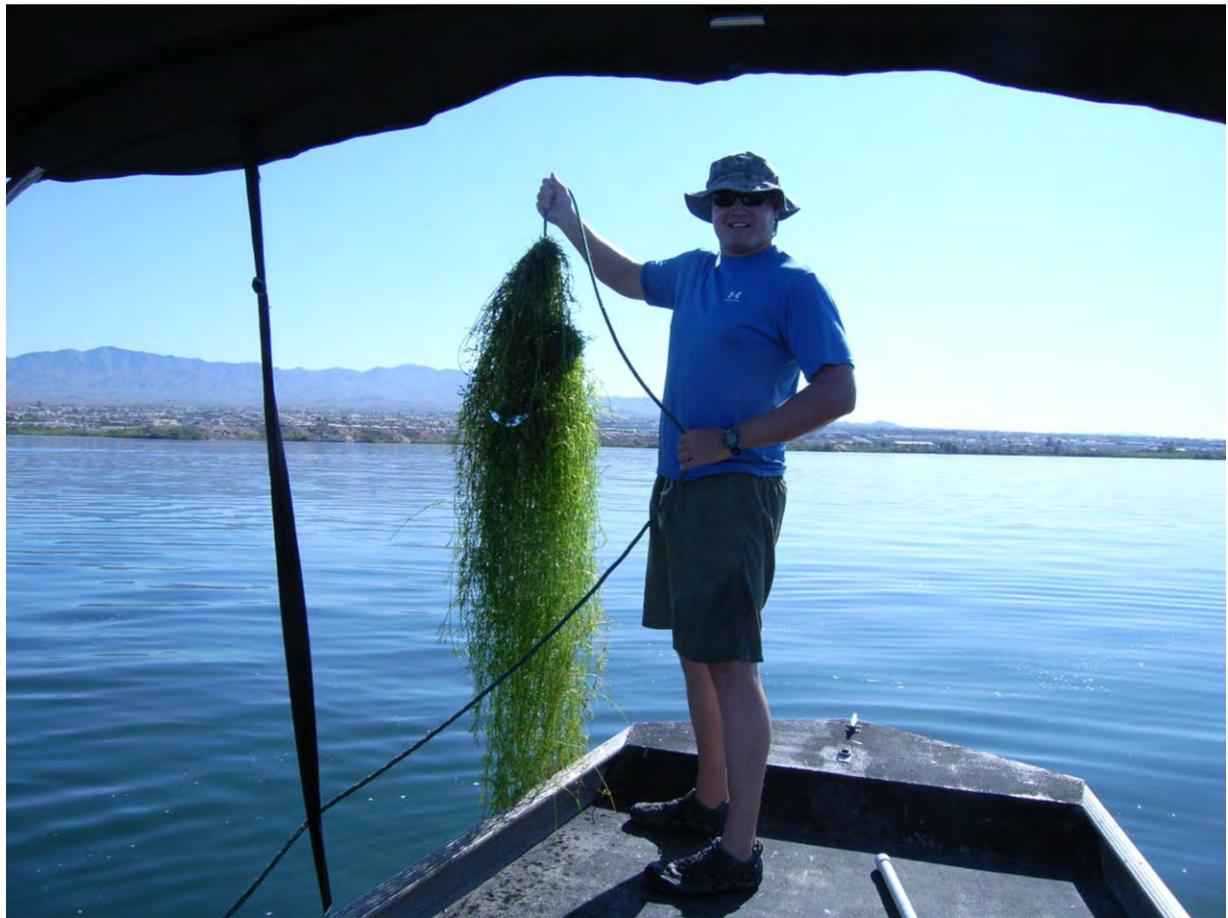
Figure 8. Scott Watson (formerly with GRI) holding a dense growth of spiny naiad (*Najas marina*) obtained from a point intercept sampling rake toss in the bay off of Lake Havasu City (background), in more than 25 ft of water depth. Photo by John Madsen.

By far the most widespread plant was spiny naiad, at 26.9% of the littoral zone, or a gross estimate of 1810 acres based on each point representing 9.9 acres (Table 2). Spiny naiad grew in dense beds in the northern end of the lake, from the north end of Lake Havasu City to the delta of the Colorado River at the inlet (Figure 7). Much of this area is from 20 to 27 feet deep, and at the time of the survey had 10’ or more of plant growth from the bottom (Figure 8). Spiny naiad grew extensively from 3 to 25 ft of water depth (Figure 9). Spiny naiad had reached the peak of its growth cycle at the time of the survey in September (see **Phenology**).

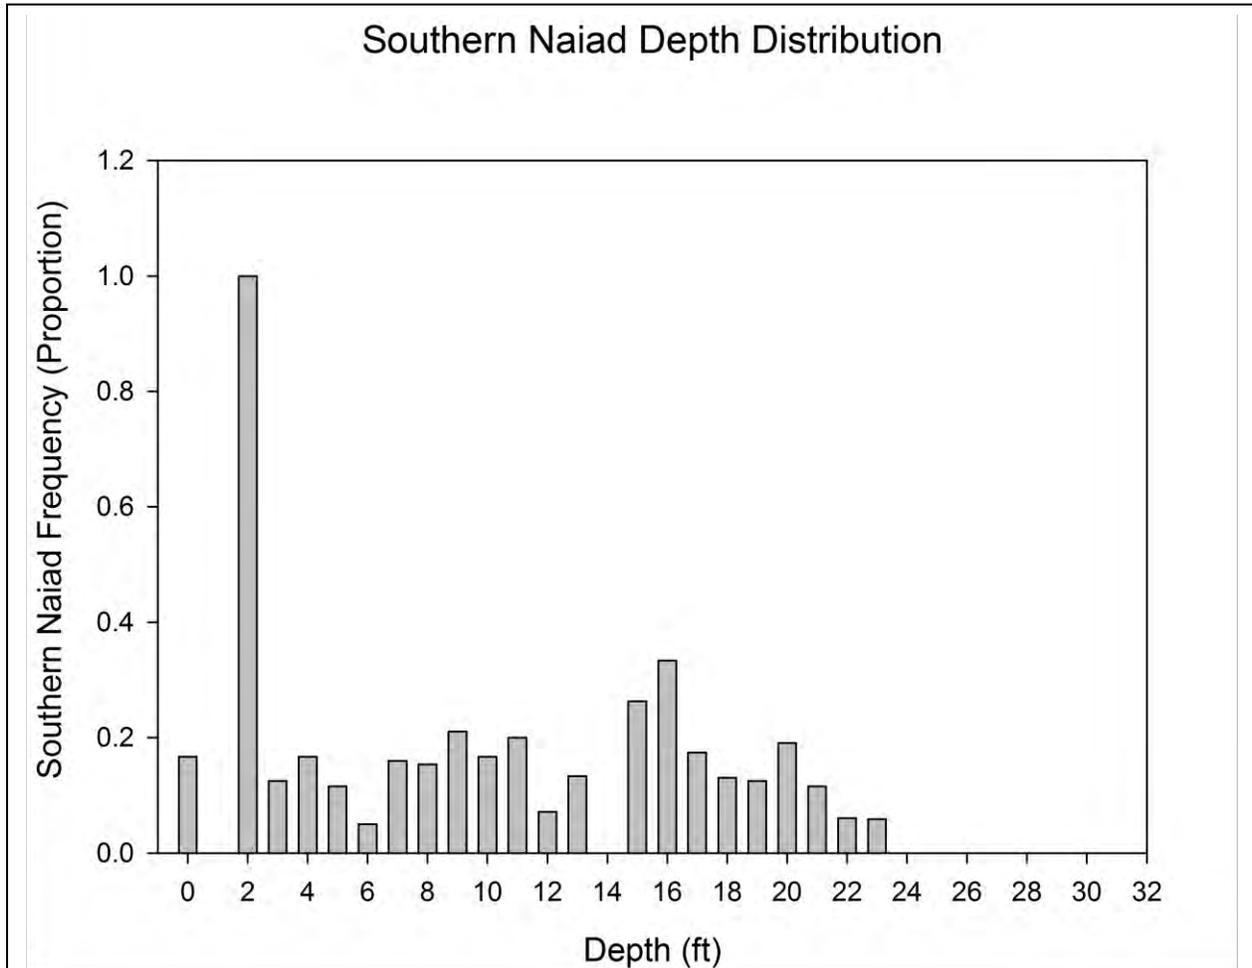
Figure 13. Depth distribution of southern naiad (*Najas guadalupensis*) by proportion of points at each depth interval with southern naiad present in Lake Havasu from a September 2011 survey.

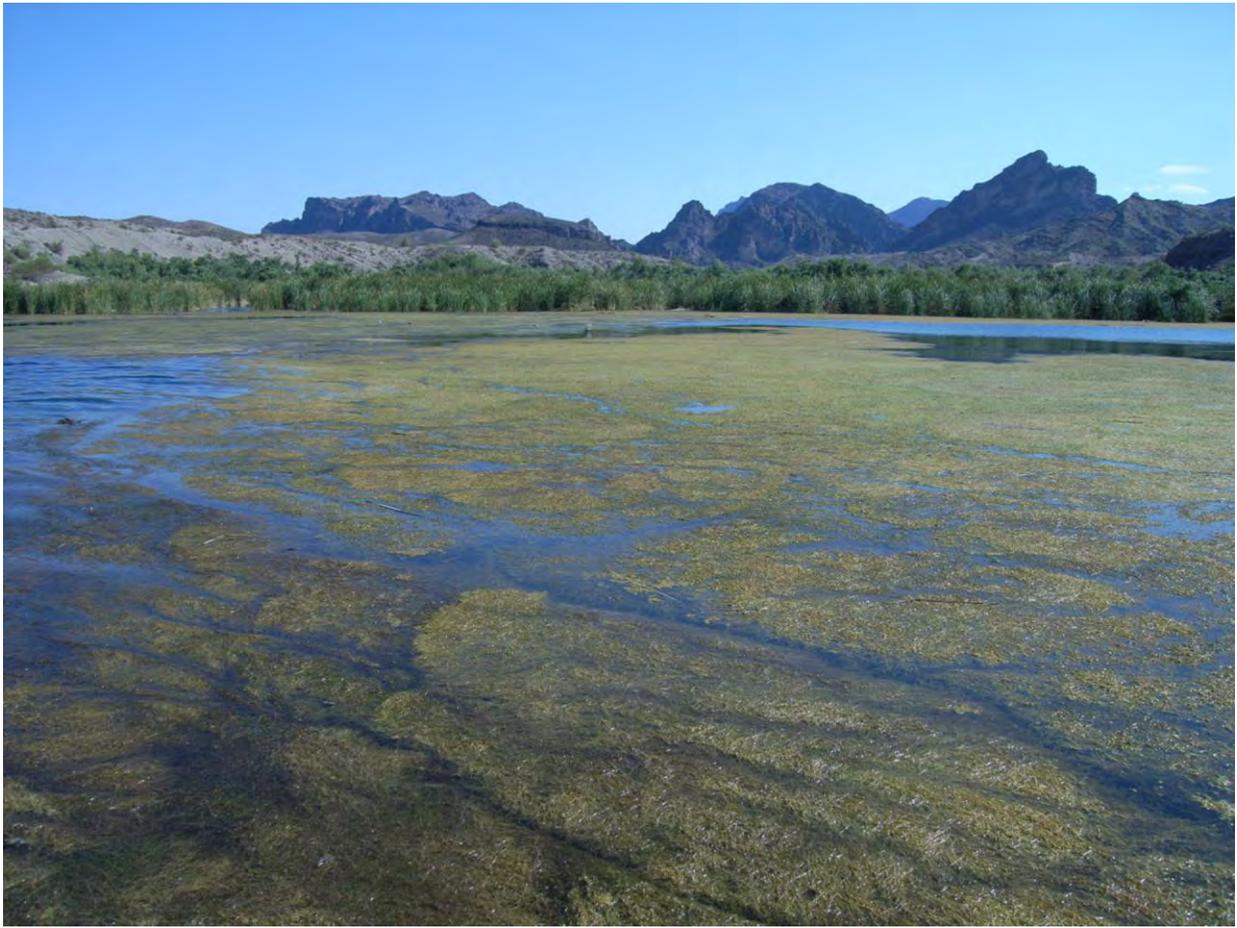
Figure 14. In many areas of Lake Havasu, large mats of dead floating plants were observed during the plant survey in September 2011. The main constituents of these mats were southern naiad, spiny naiad, and sago pondweed. Photo by John Madsen, GRI.

The third most common species (see **Biomass**) was southern naiad (*Najas guadalupensis*), which was found in about 8.4% of points for an estimated acreage of 564 acres (Table 2). Similarly to sago pondweed, it was found in shallow embayments throughout the lake (Figure 12). Southern naiad has a fairly continuous distribution across depth (Figure 13; the 2 ft depth interval has very few points). Southern naiad was well past its peak of biomass by the time of the survey, thus it may have been more common earlier in the year (see **Phenology**). Southern naiad was a major component of dead floating mats around the lake at the time of the survey, though other species were also observed (Figure 14).

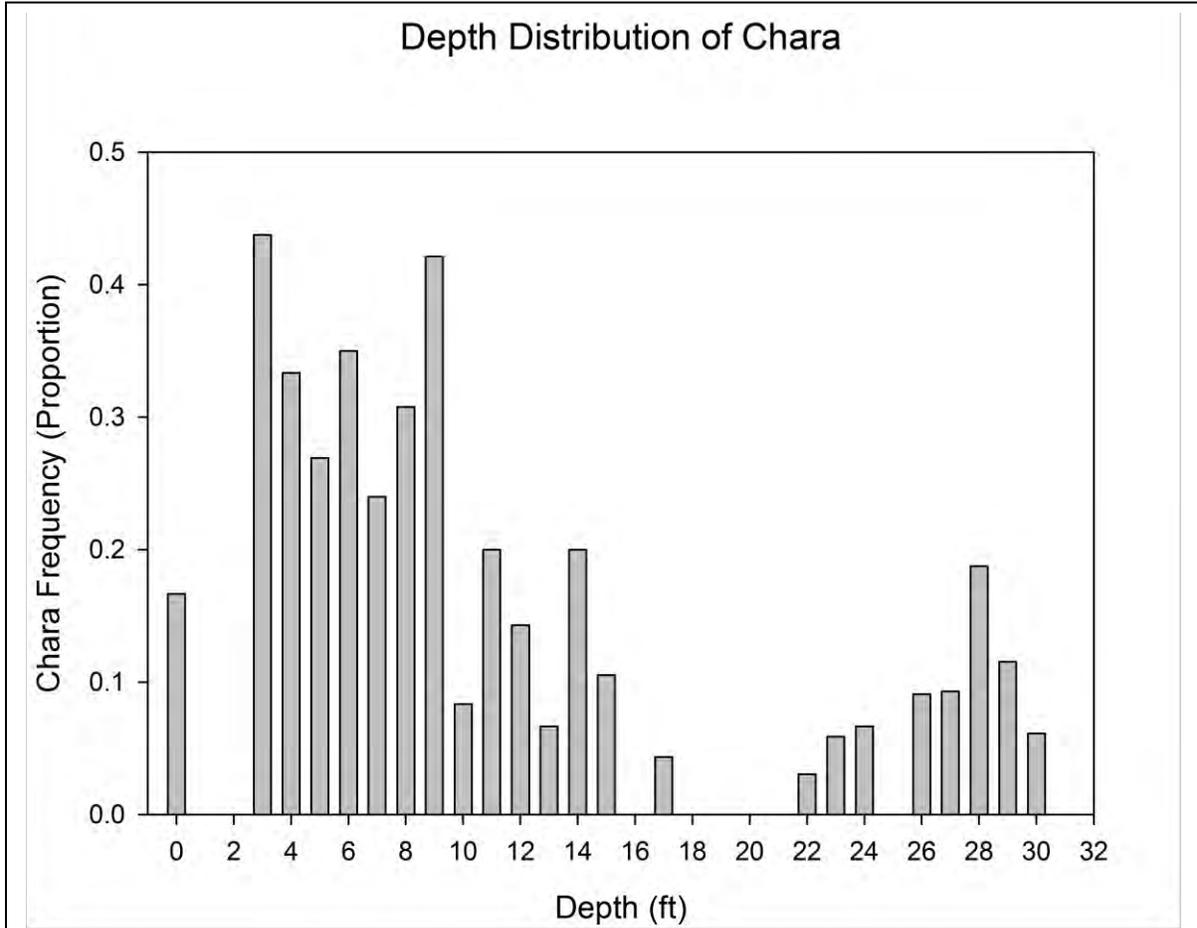
Figure 15. Depth distribution of chara (*Chara* sp.) by proportion of points per depth interval from a September 2011 survey of Lake Havasu.

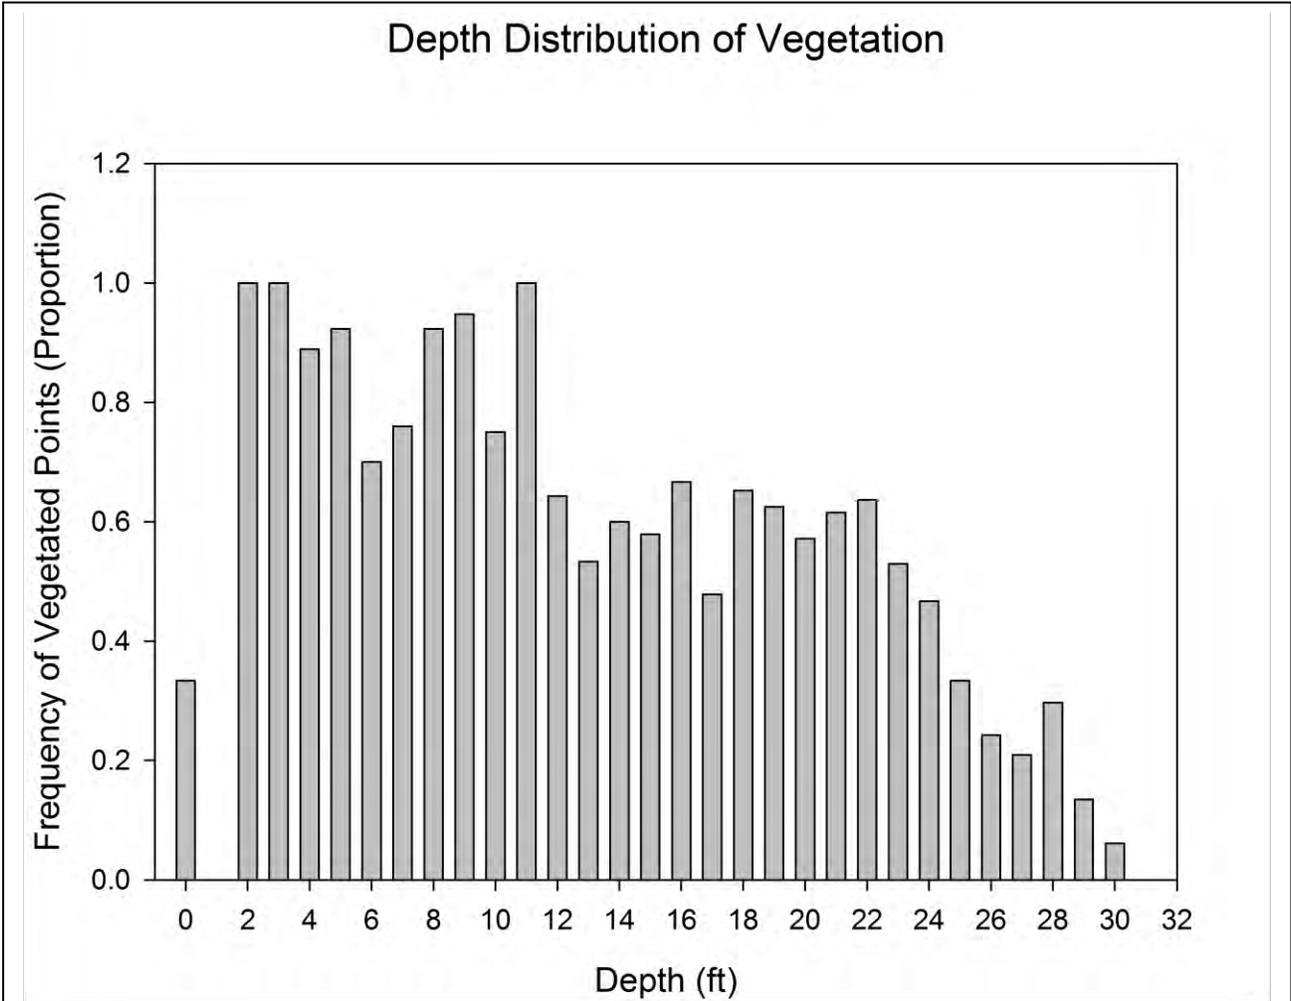
Figure 17. Depth distribution of points with vegetation, as a proportion of all points, from a point intercept survey of Lake Havasu in September 2011.

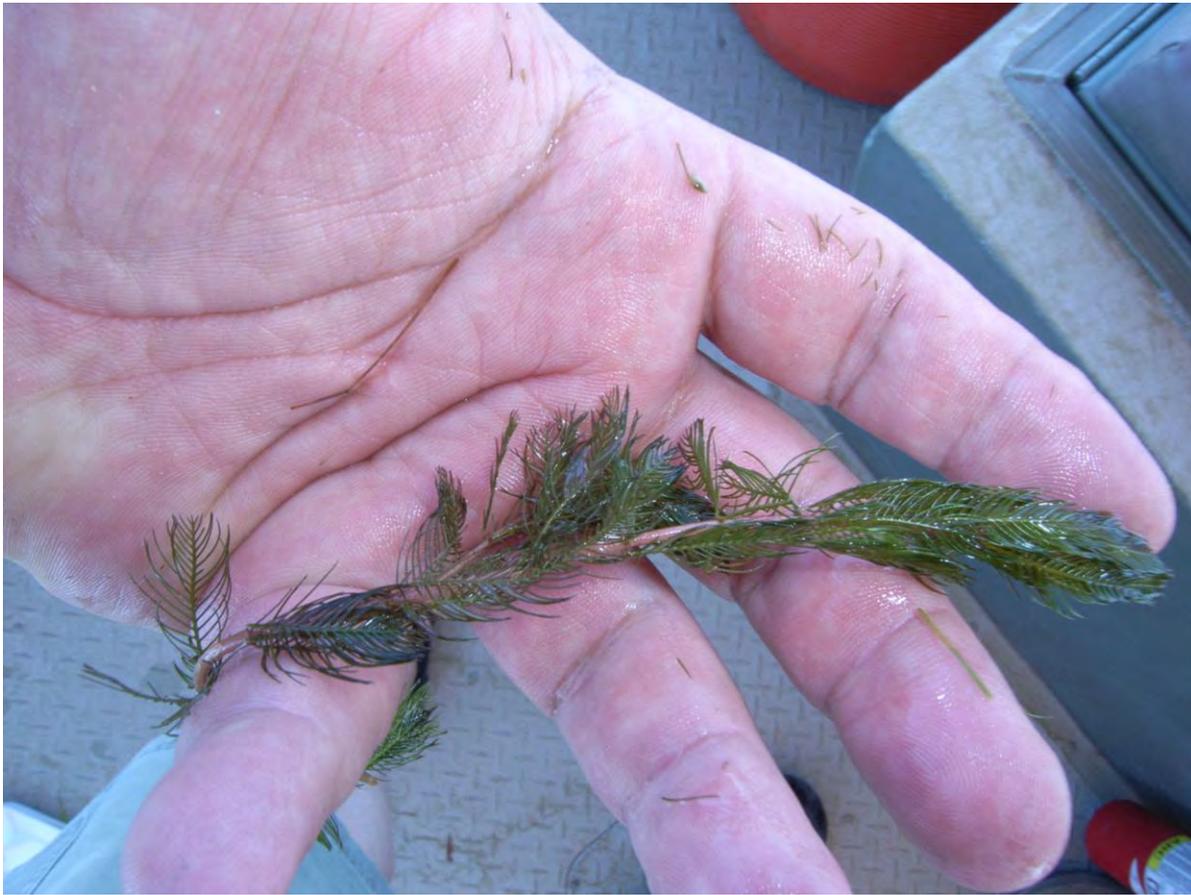
Figure 19. Eurasian watermilfoil (*Myriophyllum spicatum*) found in Lake Havasu on a reconnaissance trip, June 22, 2011. Photo by John Madsen, GRI.

Two invasive aquatic plant species were found: curlyleaf pondweed (*Potamogeton crispus*) and Eurasian watermilfoil (*Myriophyllum spicatum*; Tables 1, 2). Very few locations of curlyleaf pondweed were found (0.7%), possibly because this species is dominant in the spring and senesces to turions by early summer (Woolf and Madsen 2003). Eurasian watermilfoil was found at 3% of points, or approximately 208 acres (Table 2). Eurasian watermilfoil was not observed south of Lake Havasu City, and was found commonly near the delta of the Colorado River (Figure 18). Eurasian watermilfoil was first detected while on reconnaissance with Doug Adams of BLM, on June 22, 2011 (Figure 19). Eurasian watermilfoil has the capability to spread within the Lake Havasu system; so at a minimum, continued monitoring is warranted. Eurasian watermilfoil is an aggressive invasive plant that may displace other vegetation (Madsen et al. 1991, Madsen 2005, Madsen 2009). If Eurasian watermilfoil were to expand, displacing current species, the timing of dead mats is somewhat uncertain. Eurasian watermilfoil produces more biomass throughout the season than most natives, and some of this material dies continuously throughout the growing season. The standing biomass also tends to die in the fall, which may push the peak of dead mat formation to later in the year.

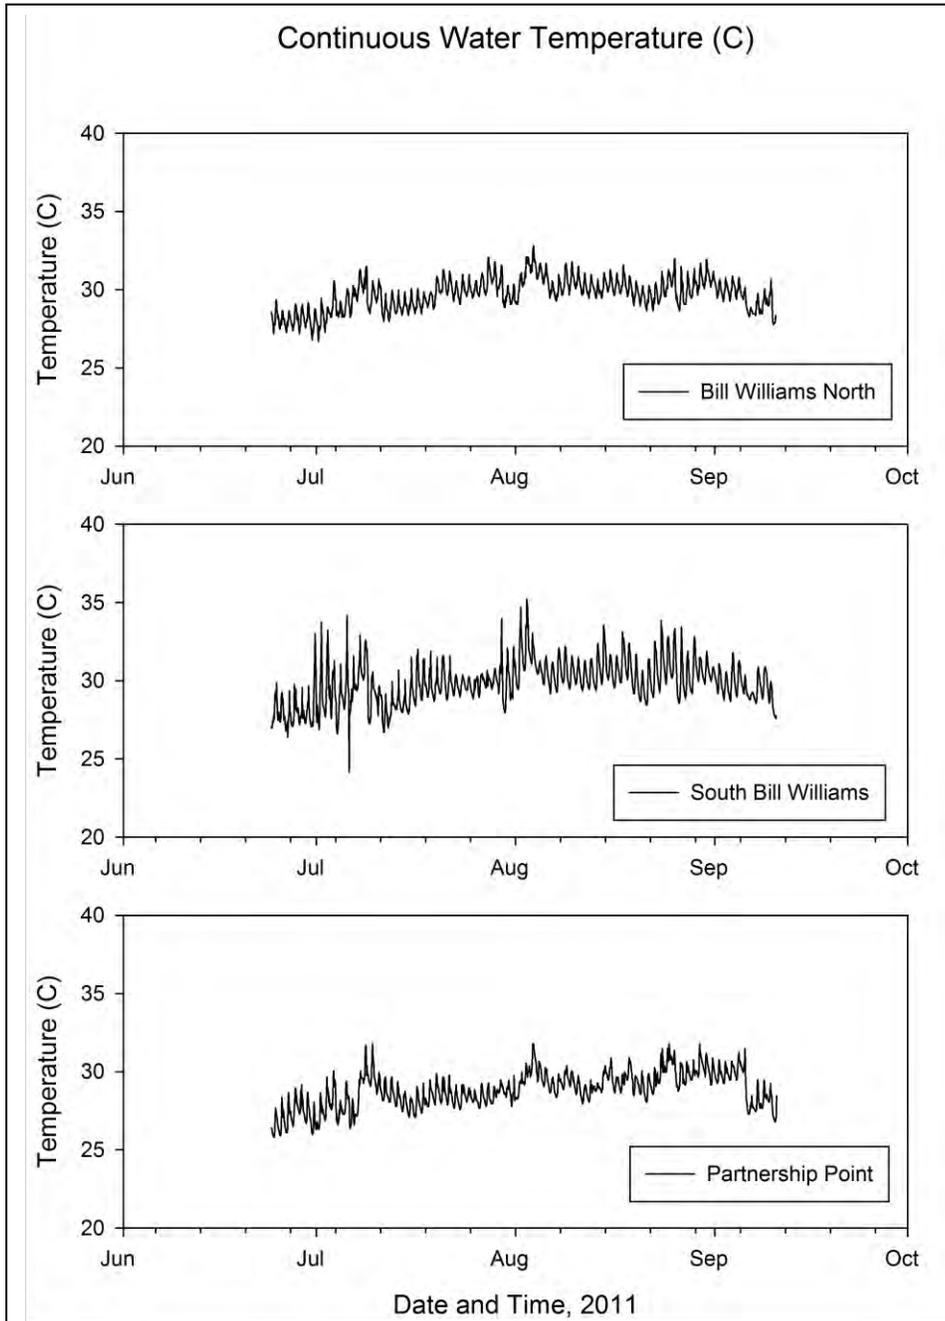
Figure 20. Continuous water temperature averaged every hour for June 24 to September 10, 2011 for probes placed near Bill Williams North, Bill Williams South, and Partnership Point.

Continuous Temperature. Water temperature recording devices were placed on permanent structures near the biomass sampling sites at Bill Williams South, Bill Williams North, and Thompson Bay. A suitable structure could not be located at Standard Wash, so this sensor was placed on the dock at Partners Point, the BLM Habitat Field Station. The sensor was lost from the Thompson Bay structure, but all the remaining three temperature sondes were recovered in September, and replaced with new sondes to carry through the winter and spring. The remaining three sondes recorded similar temperature patterns ranging from 25 to 35 C during this time (Figure 20). The sonde at Bill Williams South was covered by a dense mat of decomposing plant material.

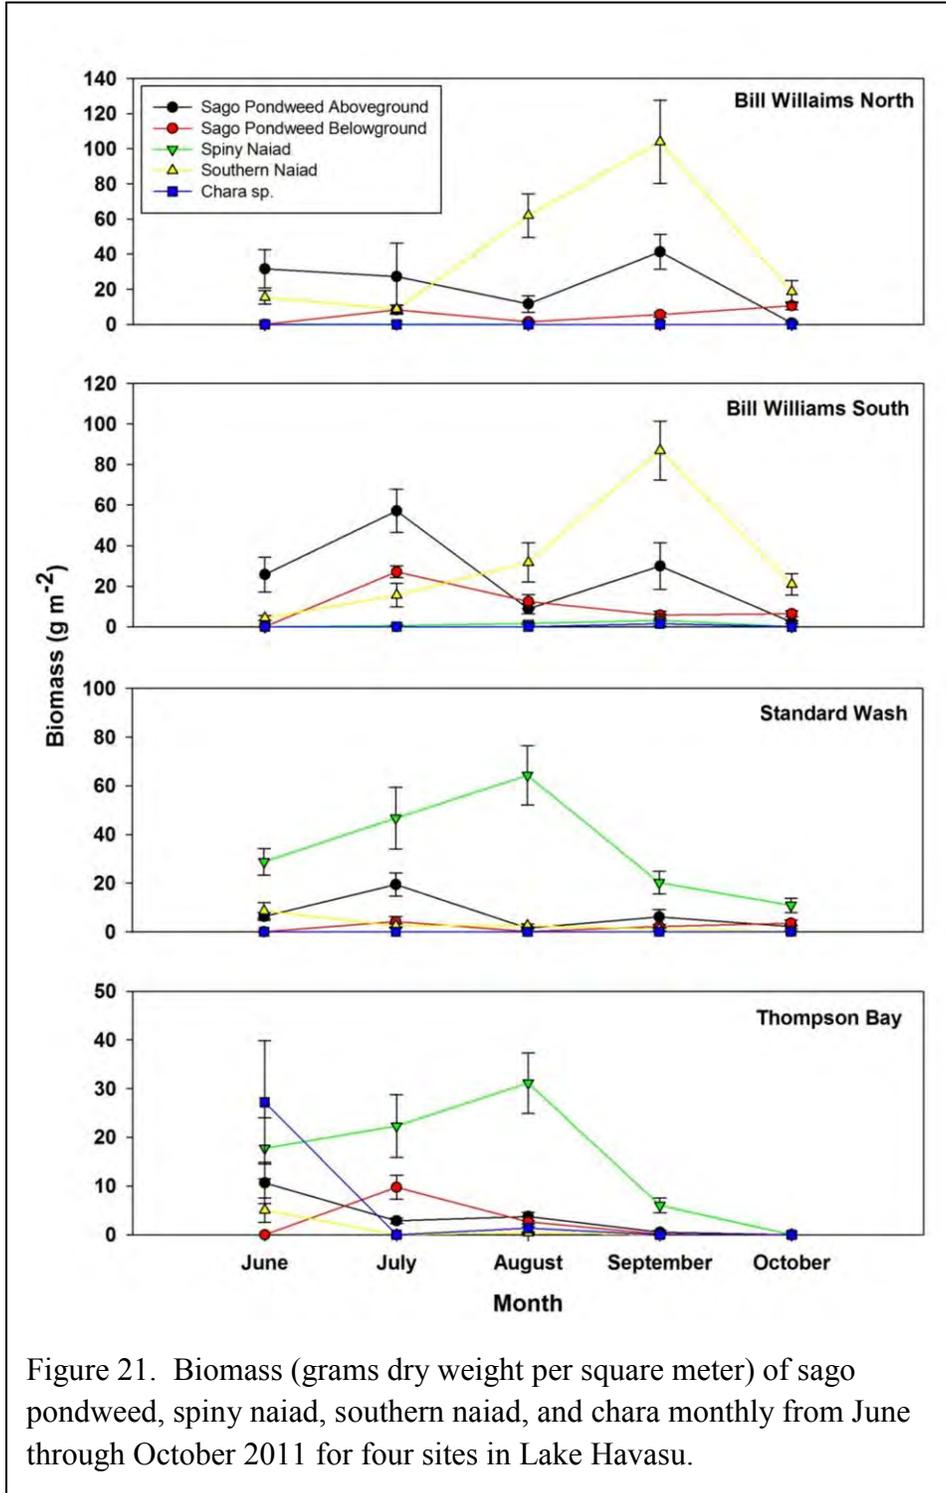
Figure 21. Biomass (grams dry weight per square meter) of sago pondweed, spiny naiad, southern naiad, and chara monthly from June through October 2011 for four sites in Lake Havasu.

Southern naiad is the dominant species at both Bill Williams sites, with a peak of 100 g/m². Southern naiad reaches maximum biomass in September, and senesces rapidly after that time. Spiny naiad is the dominant species at the remaining two sites (Standard Wash and Thompson Bay), with a maximum biomass of 70 g/m². Spiny naiad has a biomass peak in August, but declines more gradually than the other two species after that peak (Figure 21).

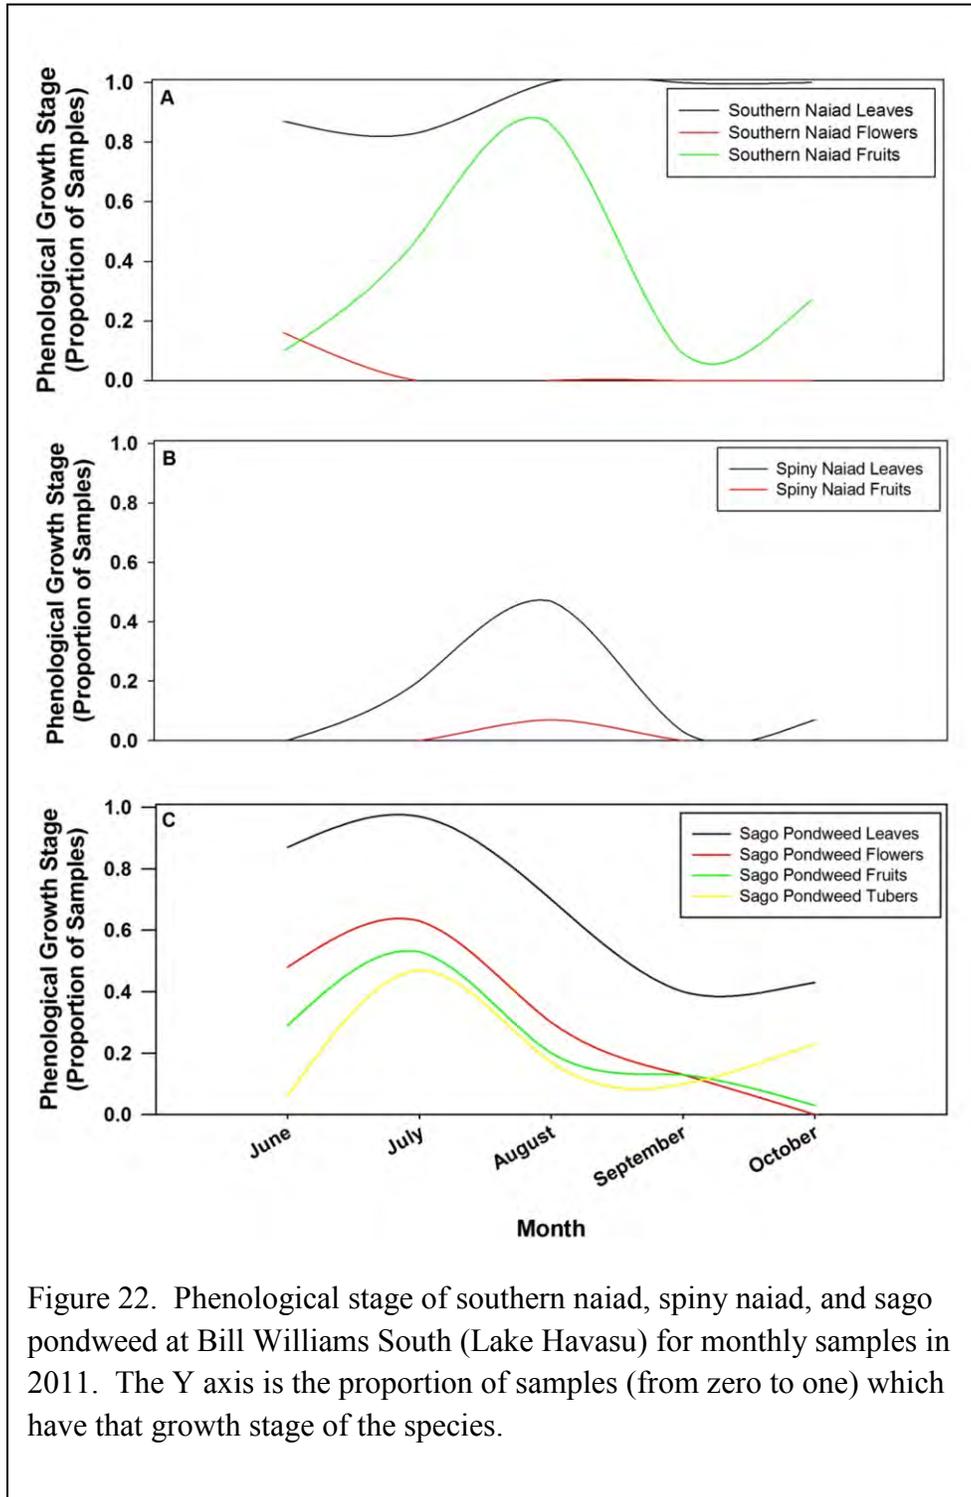
Figure 22. Phenological stage of southern naiad, spiny naiad, and sago pondweed at Bill Williams South (Lake Havasu) for monthly samples in 2011. The Y axis is the proportion of samples (from zero to one) which have that growth stage of the species.

We also looked at the proportion of biomass samples which had foliage, flowers and fruits of each of the three dominant species. At Bill Williams South (Figure 22), southern naiad flowering peaked in August, with foliage found throughout the sampling periods. Spiny naiad had a more distinct peak in August, but was not a common component at this site. Sago pondweed peaked in July.

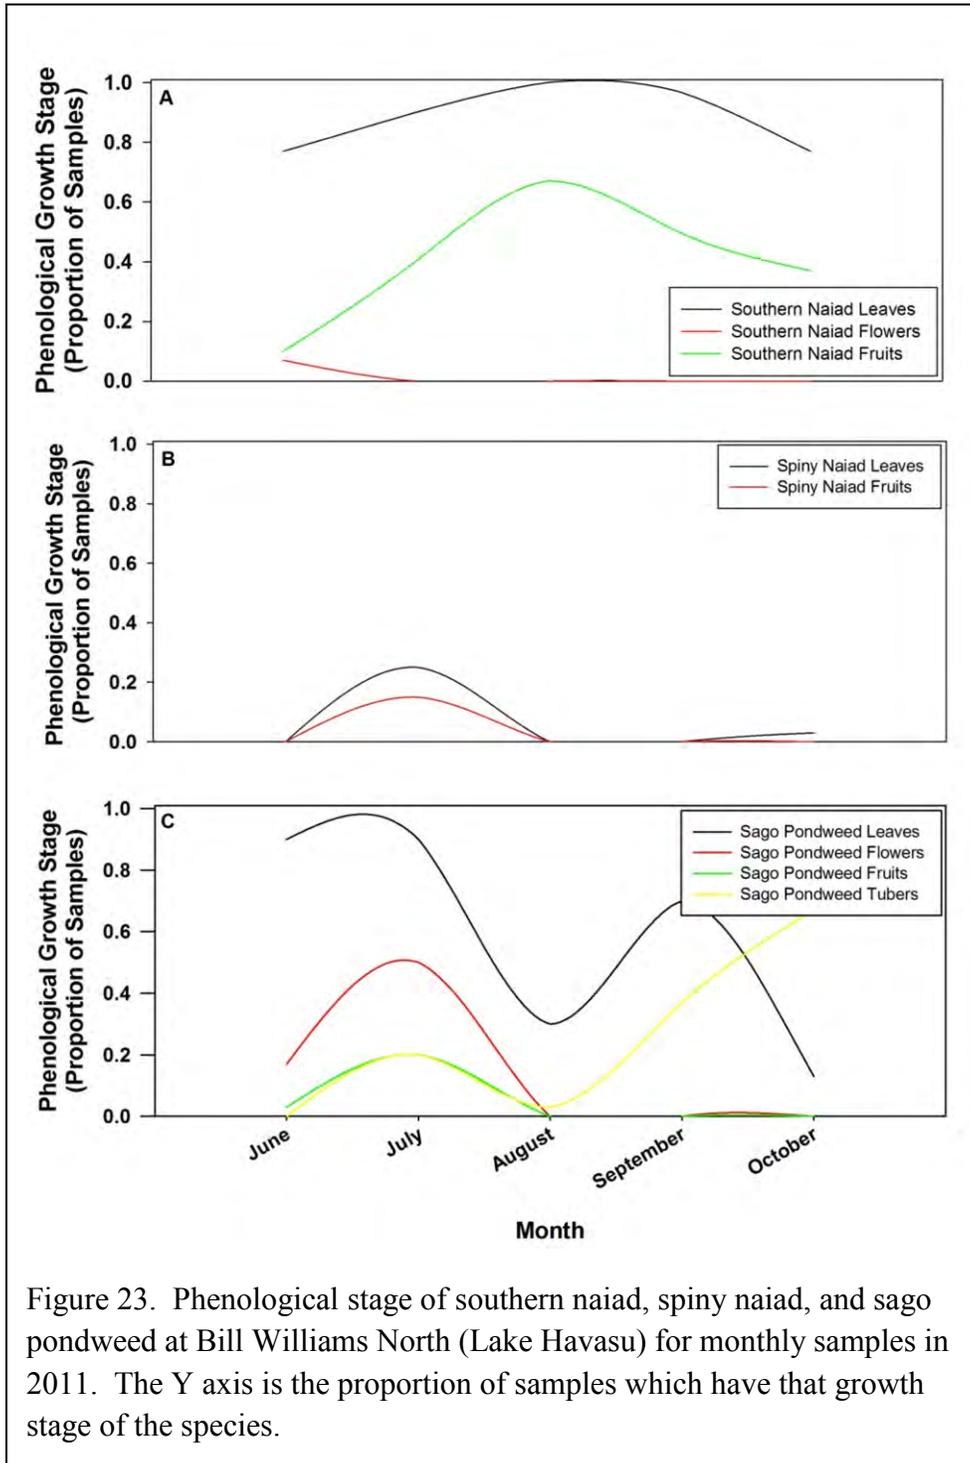
Figure 23. Phenological stage of southern naiad, spiny naiad, and sago pondweed at Bill Williams North (Lake Havasu) for monthly samples in 2011. The Y axis is the proportion of samples which have that growth stage of the species.

At Bill Williams North (Figure 23), southern naiad peaked in August. Spiny naiad was a negligible component at this site. Sago had a strong peak in July, followed by a peak in September of foliage. Tubers became the predominant life stage in October.

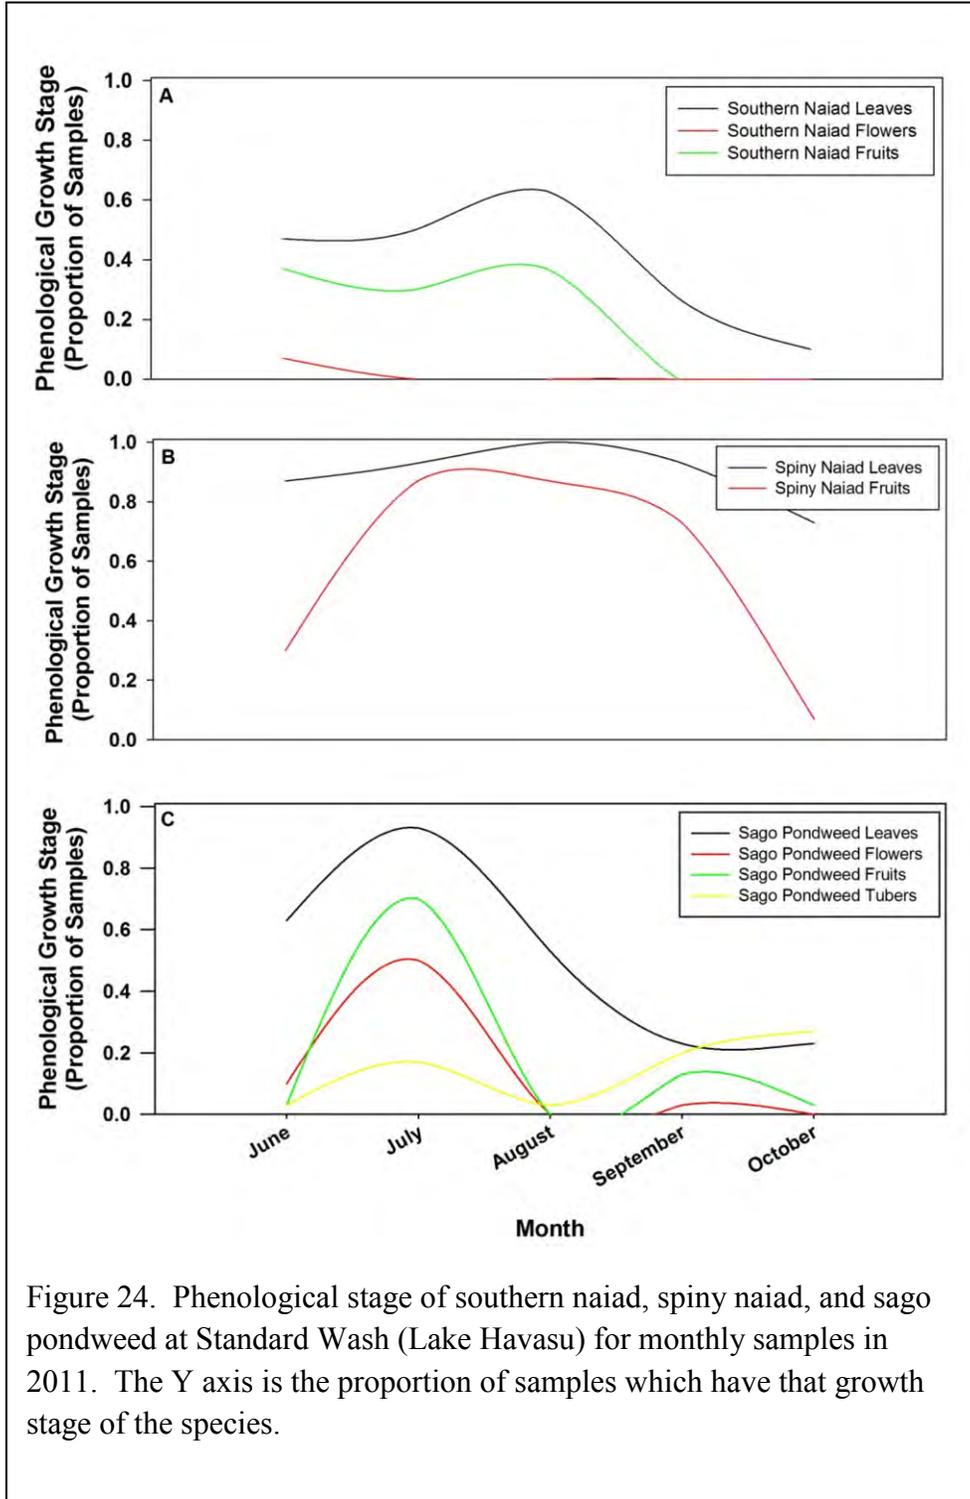
Figure 24. Phenological stage of southern naiad, spiny naiad, and sago pondweed at Standard Wash (Lake Havasu) for monthly samples in 2011. The Y axis is the proportion of samples which have that growth stage of the species.

At Standard Wash (Figure 24), southern naiad peaked in August, and spiny naiad had broad amplitude across August and September. Sago pondweed followed a similar pattern here as in Bill Williams North, with a strong peak in July, followed by a secondary peak in September.

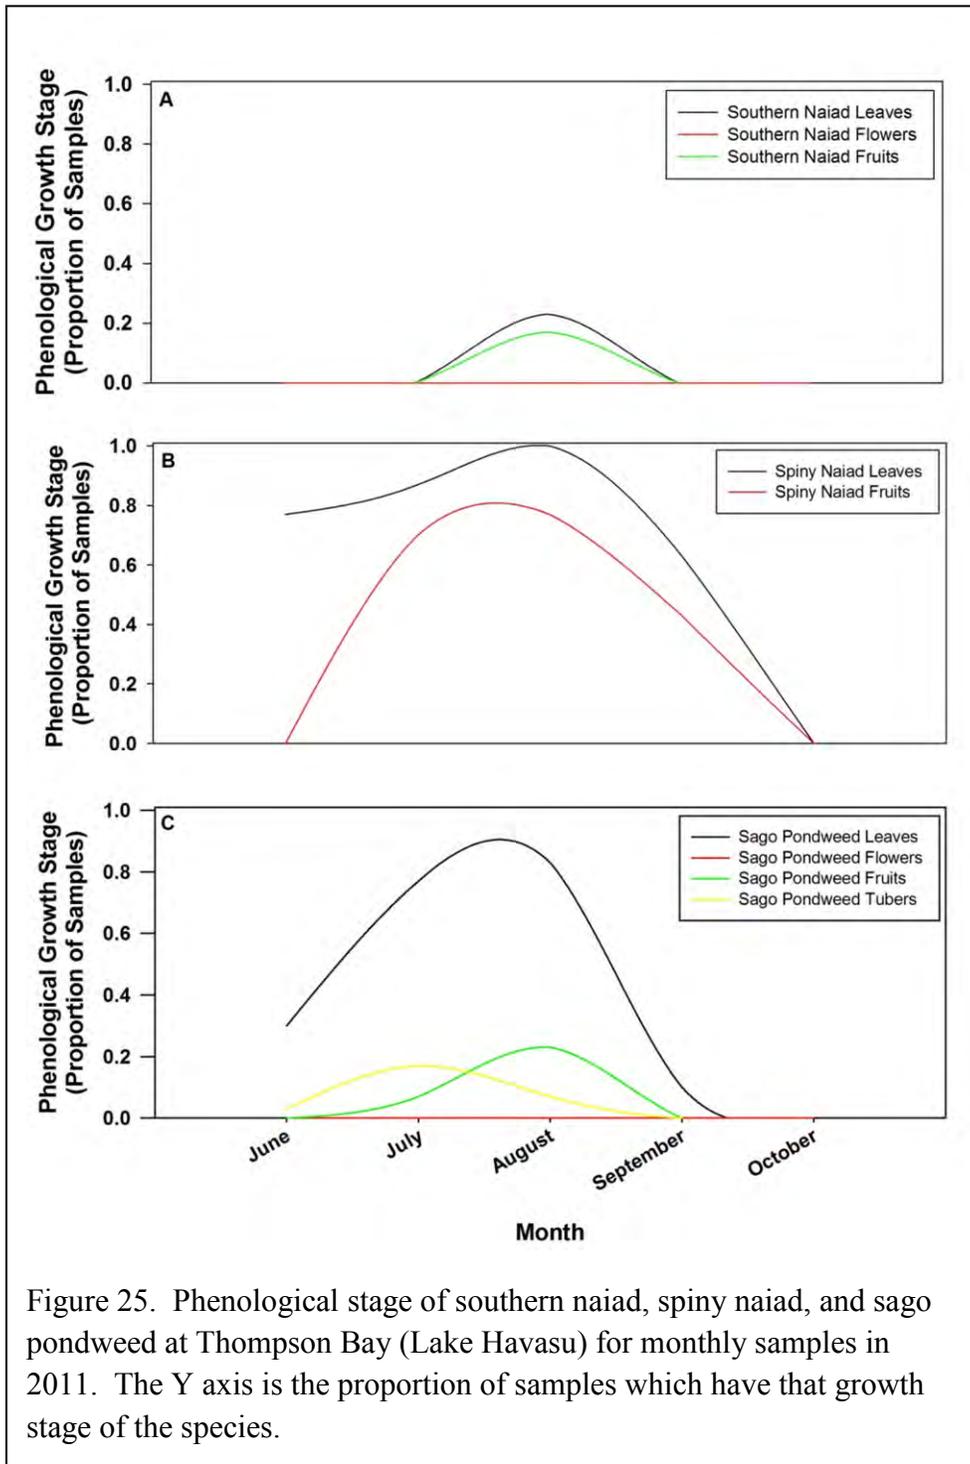
Figure 25. Phenological stage of southern naiad, spiny naiad, and sago pondweed at Thompson Bay (Lake Havasu) for monthly samples in 2011. The Y axis is the proportion of samples which have that growth stage of the species.

Thompson Bay (Figure 25) was dominated by spiny naiad and sago pondweed. Southern naiad was negligible at this site, but what grew here peaked in August. Spiny naiad peaked from July through August. Sago pondweed foliage peaked in July and August, with fruits appearing in August and tuber formation beginning in July.

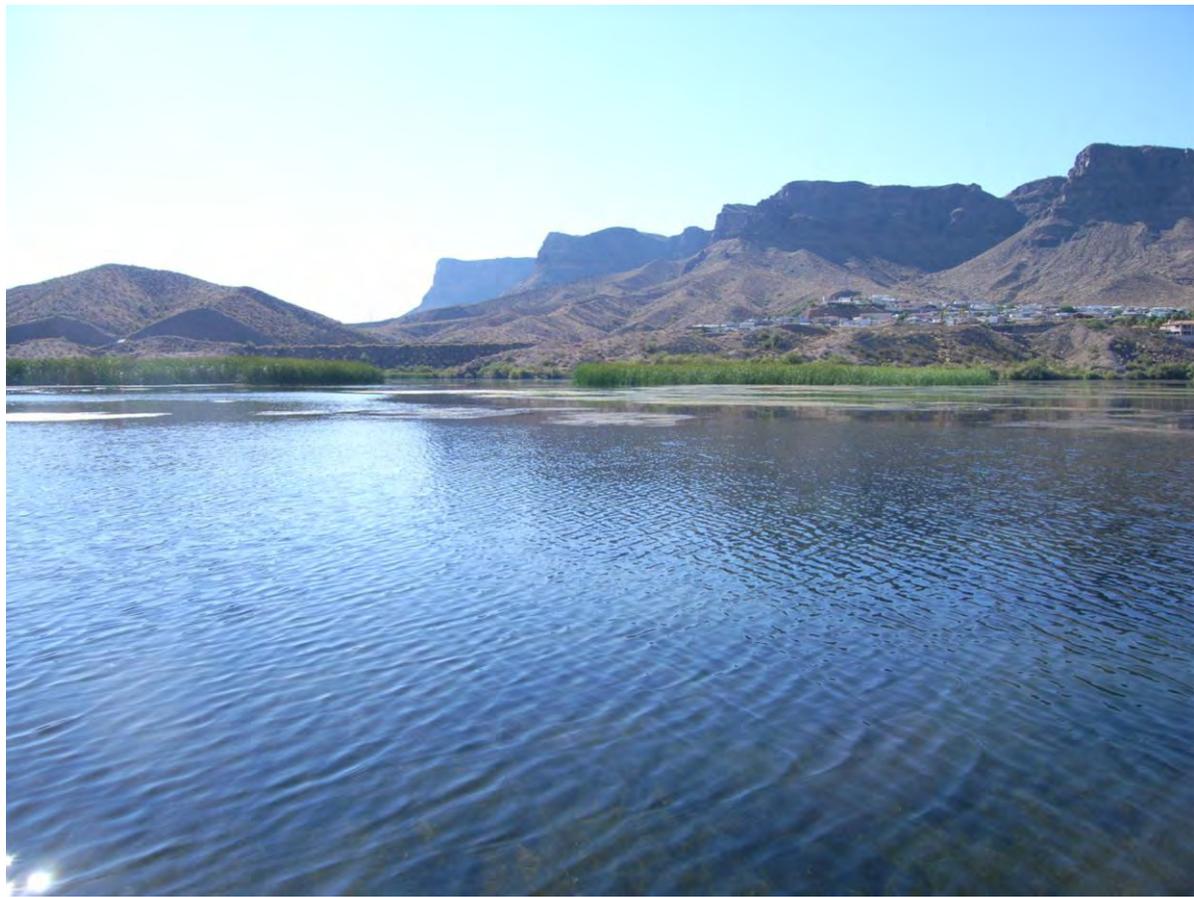
Figure 27. Mats of predominantly southern naiad forming in the Bill Williams bay area, September 2011.

The composition of floating mats provides some substantiation for the observations made regarding phenology above, with sago pondweed occurring first, followed by southern naiad and spiny naiad (Figure 26). Two inconsistencies do arise regarding the composition of the mats arriving at Mark Wilmer: 1) the late peak in southern naiad, and 2) the high proportion of spiny naiad. Southern naiad is resurgent in the mats late in August. This may in part be that the mats often are not completely dead, and the shoots can survive for a long period of time. Mats in the Bill Williams area started appearing in August, and persisted into October (Figure 27). While

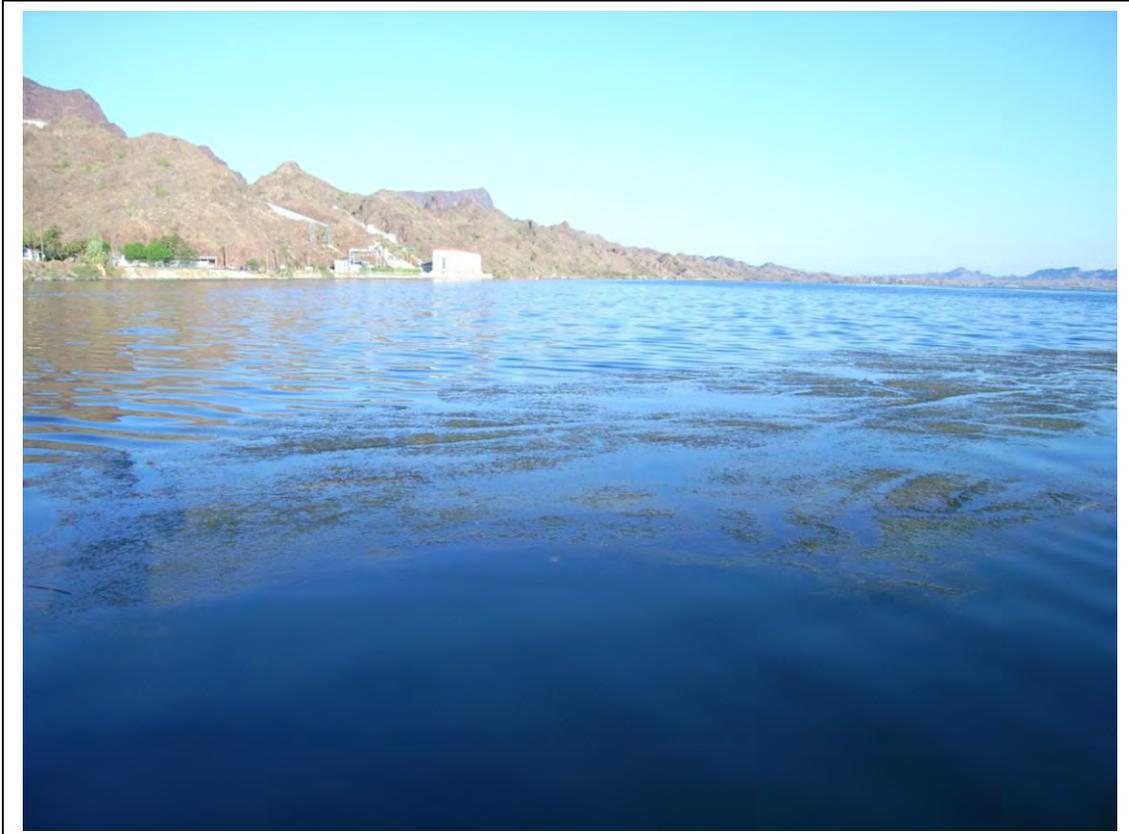
Figure 28. Mat floating in the open water on Lake Havasu, September 7, 2011. Metro pumping station on California side is visible in the background.
