Lake Havasu Aquatic Plant Monitoring 2011 Interim Report

An Interim Report Submitted to RNT Consulting and the Central Arizona Project
John D. Madsen, Ryan M. Wersal, Amanda Fernandez and Gray Turnage
Geosystems Research Institute, Mississippi State University

GRI Report #4008

April 16, 2012

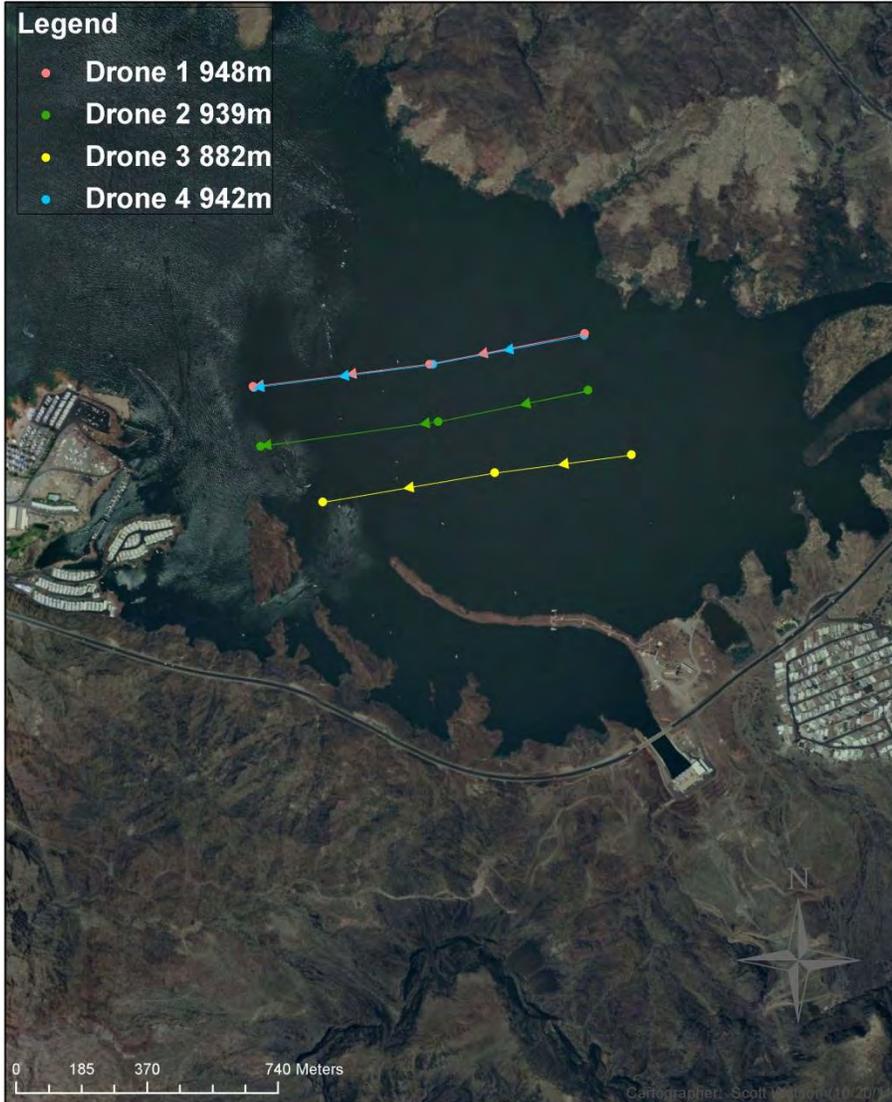
Lake Havasu Drift Study Sept. 10, 2011

Figure 29. First drone release location in Bill Williams on September 10, 2011.

On September 10, winds were out of the south with maximum sustained winds of 17mph and gusts up to 32 mph. Four drones were released in open water about 20m from the large plant beds (Figure 29). After two hours, the drones were collected. They had moved west, past the pumping station inlet, averaging 4.25 feet per second (initially reported as 464 meters (m) per hour) (Figure 29). The four drones were then released in pairs at the mouth of the inlet leading to the pumping station and allowed to float for thirty minutes. Both pairs drifted northwest away from the pump (Figure 30). The four drones were released a final time in spots that were farther south than the first release locations (Figure 31). Three of the drones were free-floating while one was placed on a plant bed. The three free floating drones moved northwest at 7.10 feet per second (initially reported as 774 meters per hour) while the drone sitting on the plant mat moved in the same direction but only at 2.21 feet per second (initially reported as 242 meters per hour) (Figure 31).

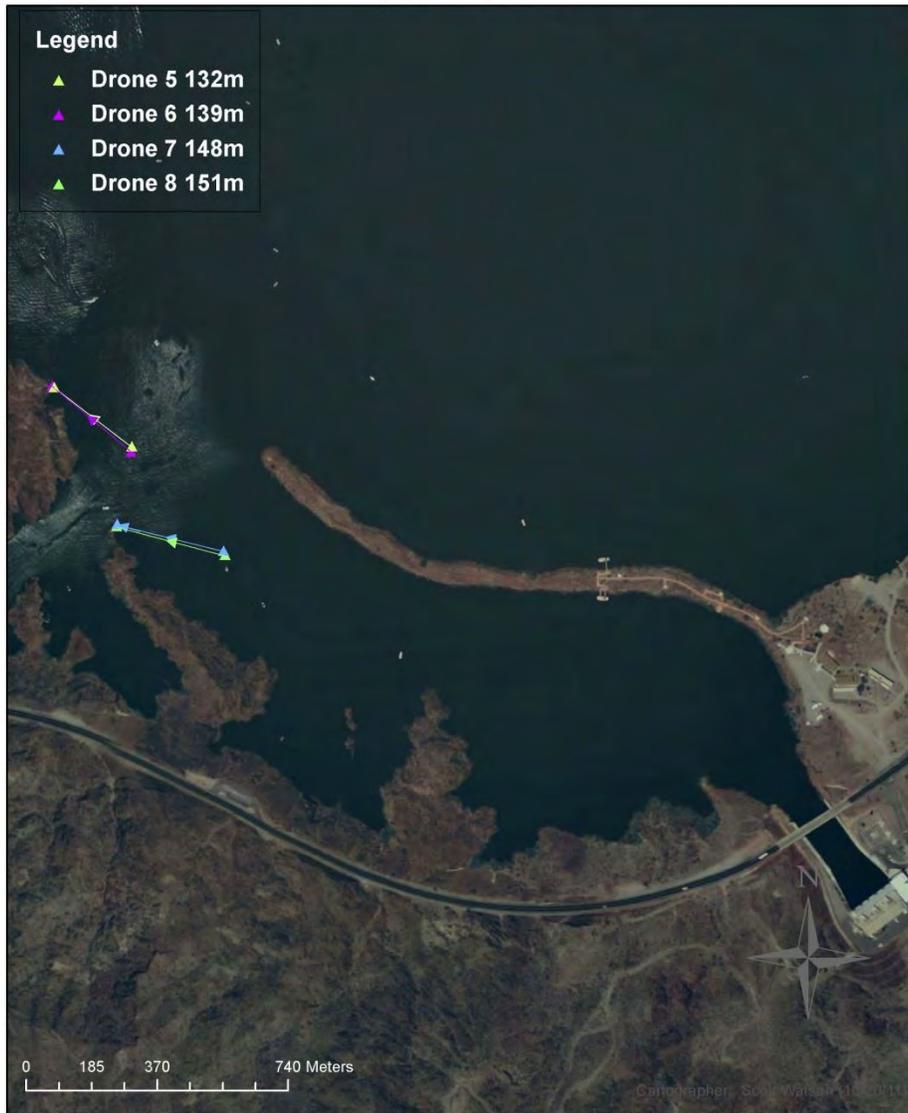
Lake Havasu Drift Study Sept. 10, 2011

Figure 30. Drone release location at the mouth of the pump inlet in Bill Williams on September 10, 2011.

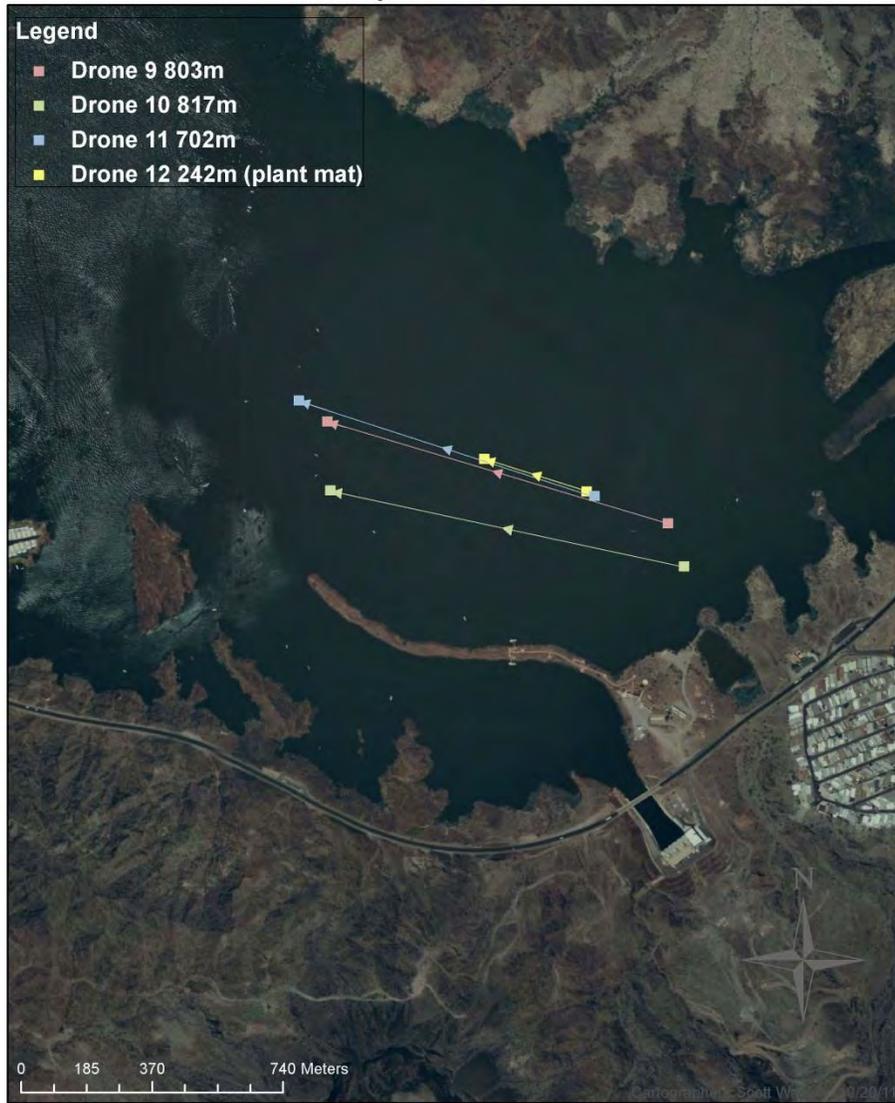
Lake Havasu Drift Study
Sept. 10, 2011

Figure 31. Final drone release location in Bill Williams on September 10, 2011.

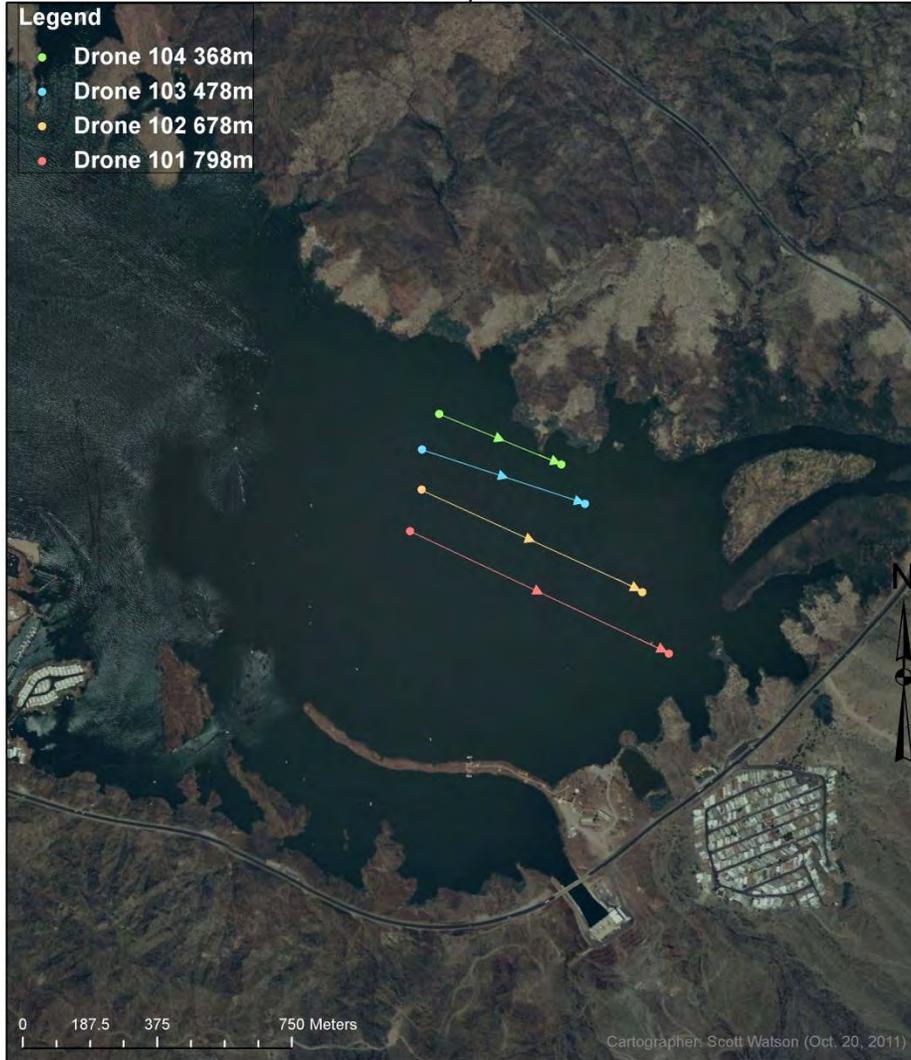
Lake Havasu Drift Study
Oct. 9, 2011

Figure 32. First drone release location in Bill Williams on October 9, 2011.

On October 9, winds were from the north northwest with maximum sustained wind speed of 15mph and gusts up to 24mph. In addition, the Mark Wilmer pumps were running. Four drones were released in the northern half of Bill Williams and drifted east deeper into the wildlife refuge (Figure 32). To see if the pump could create enough suction to pull the drones around the peninsula that creates the inlet to the pump, five drones were released on both sides of the peninsula (Figure 33). The two drones above the peninsula were not pulled around it but instead were moved southeast. The drone released exactly above the peninsula point moved below the peninsula and into the inlet, and the two drones released below the peninsula moved southeast into the inlet (Figure 33).

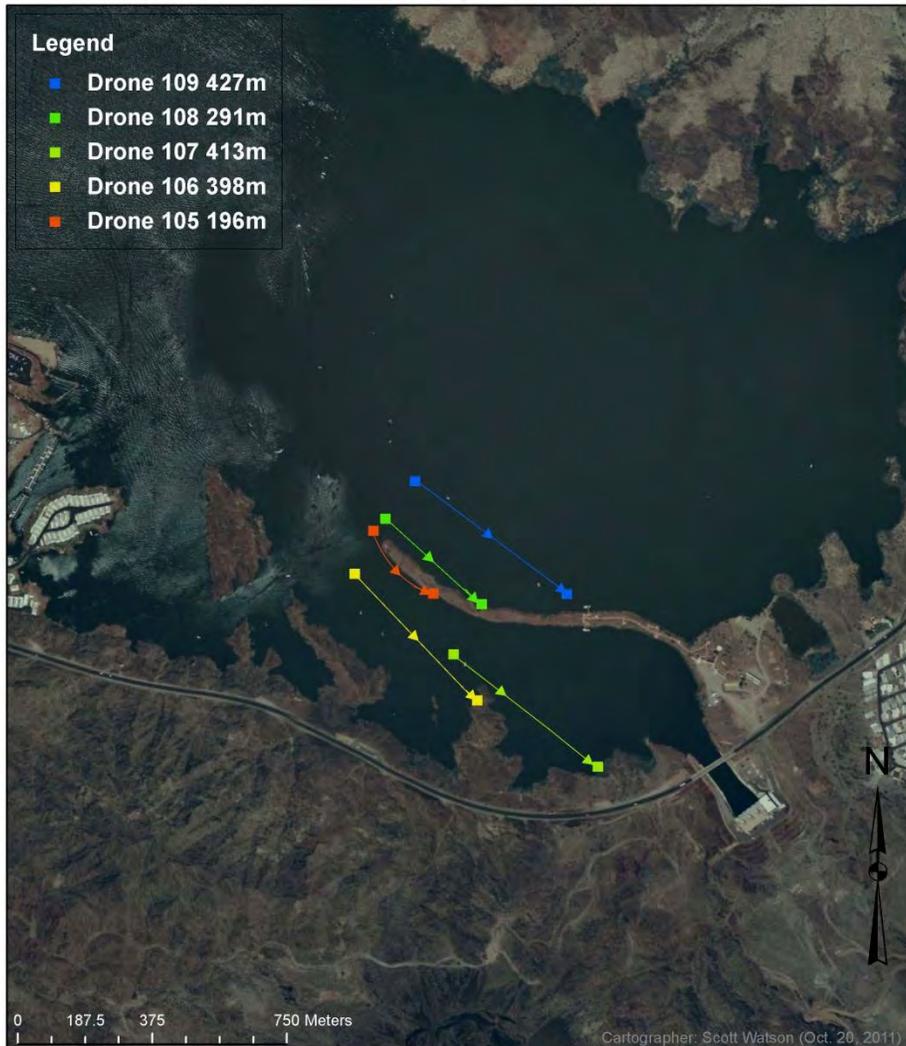
Lake Havasu Drift Study
Oct. 9, 2011

Figure 33. Drone release surrounding the peninsula in Bill Williams on October 9, 2011.
