Catalpa Creek Watershed Planning, Restoration, and Protection Project

Abstract

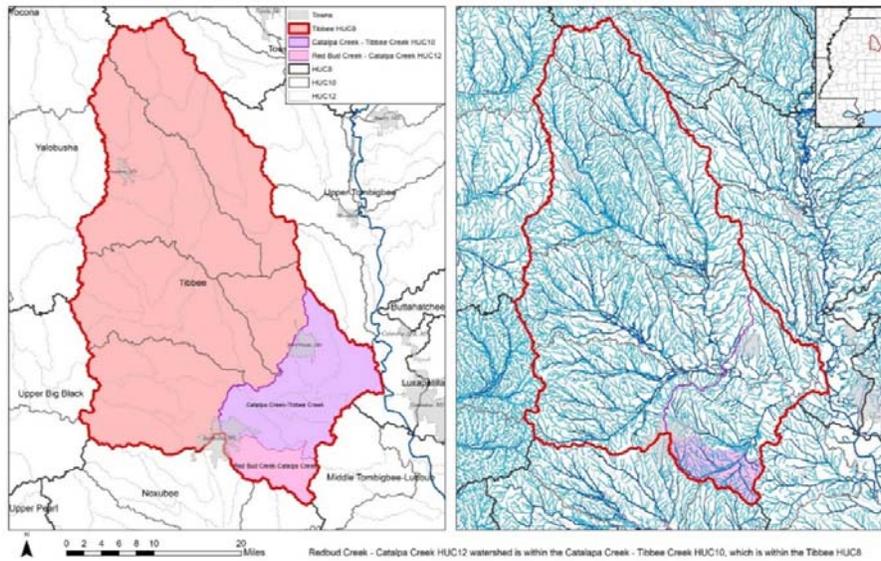
Figure 1 | Hydrologic Features of the Red Bud – Catalpa Creek Watershed.

The Red Bud-Catalpa Creek Watershed is located in Oktibbeha and Lowndes counties in the northeast region of Mississippi and is part of the larger Tombigbee River Basin (Figure 1). The 11,706 ha watershed contains 50 km of mainstream perennial stream length (Figure 2). The stream network empties into Tibbee Creek, which flows into Columbus Lake on the Tennessee-Tombigbee Waterway north of Columbus, MS. At the HUC-12 (subwatershed) level, the watershed includes part of the Mississippi State University (MSU) Campus, the MSU HH Leveck research facility and dairy farm, as well as a number of privately owned lands. Originally, the land in the watershed was primarily prairie. Current land use includes 44% in hay production/pasture land, 10% in cultivated crops, 9% in developed land, and 8% in wetlands or open water (Figure 3).

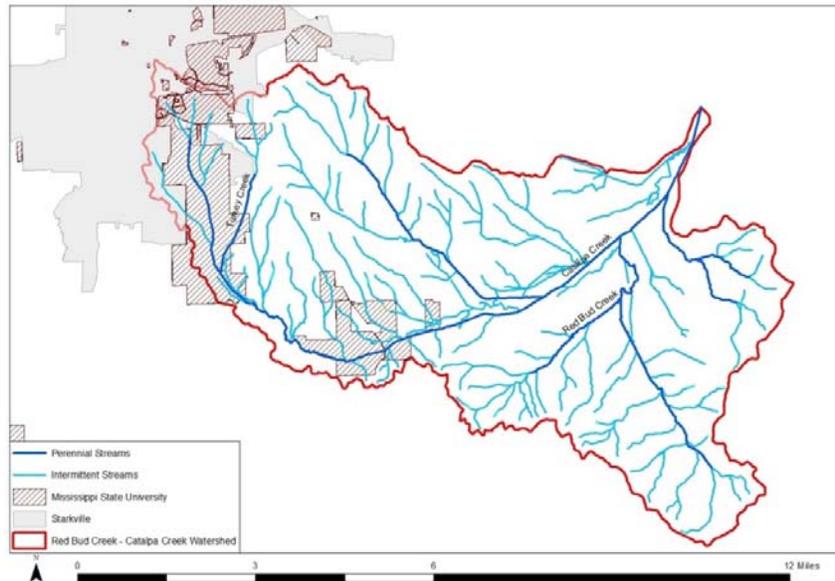
Figure 2 | Main stem (perennial) and tributary (intermittent) streams in the Red Bud Creek – Catalpa Creek Watershed

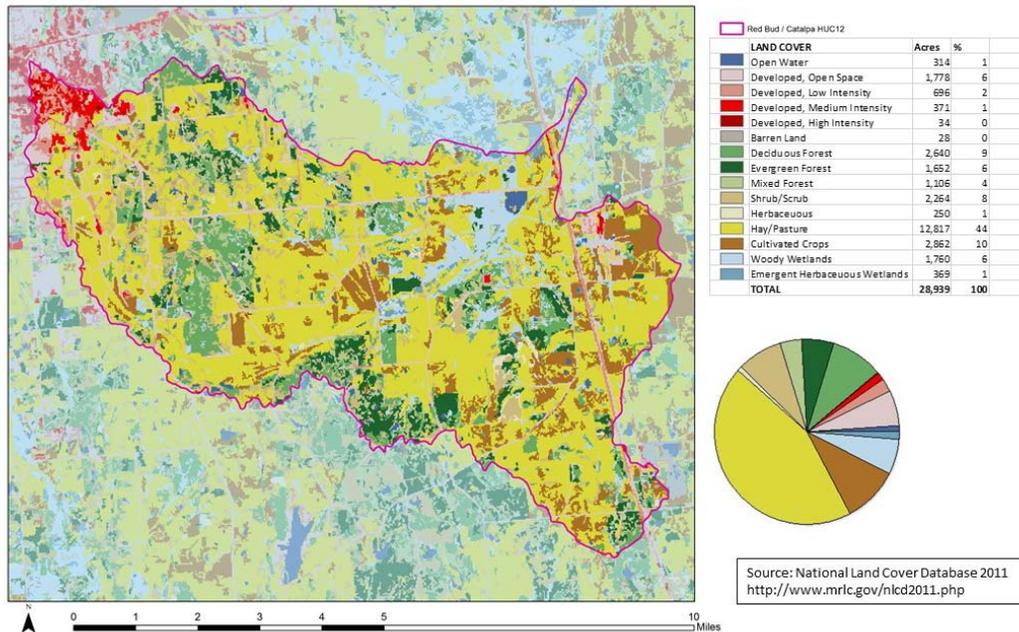
Figure 3 | Land Use in the Red Bud - Catalpa Creek Watershed.

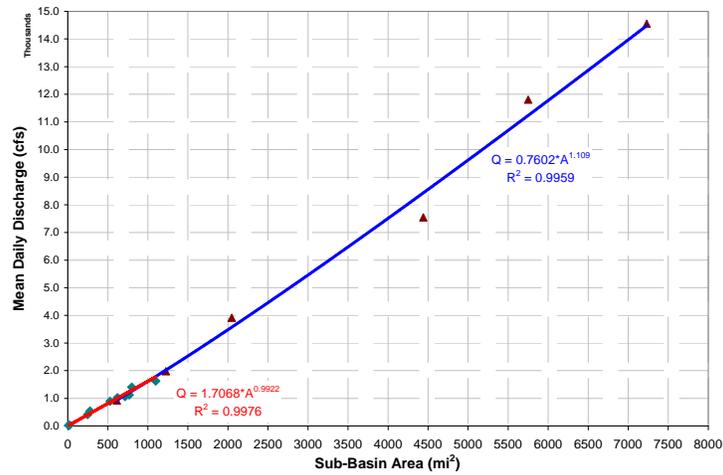
Figure 4 | Relationship between basin area and mean daily streamflow for tributaries sub-basins (red) and locations along the Tombigbee River and the Tenn-Tom Waterway (blue)

Due to the lack of streamflow information, studies completed by MSU researchers to develop a water and a sediment budget along the Tombigbee River Basin are used as a reference to approximate the hydrologic response for the Red Bud - Catalpa Creek Watershed. Considering the relationships between drainage area and mean daily discharge (Figure), and between drainage area and bankfull discharge (assumed as the streamflow at a recurrence interval of 1.5 years ($Q_{1.5}$)) (Figure 5), generated by Ramirez-Avila *et al.* (2013) and Ramirez-Avila *et al.* (2015a) for tributary sub-basins within the Tombigbee River Basin, the mean daily discharge (\bar{Q}) and the bankfull discharge at the outlet of the 11,706 ha are $2.12\text{m}^3/\text{s}$ and $57\text{m}^3/\text{s}$, respectively.

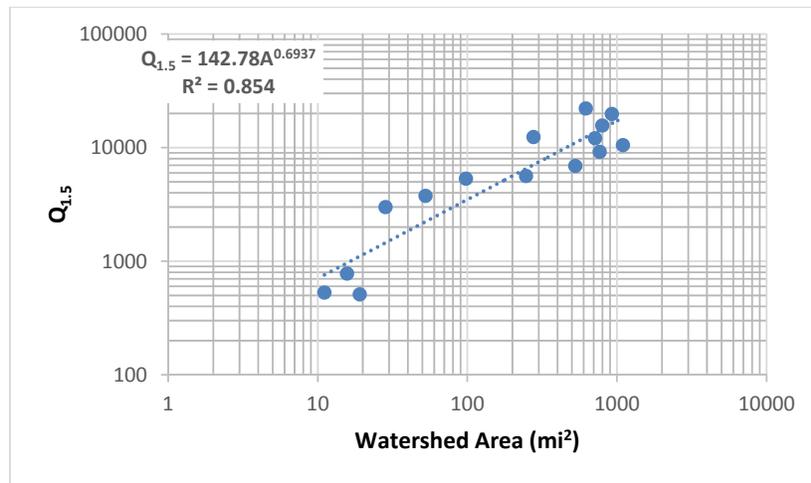
Figure 5 | Regional bankfull discharge (Q1.5) – watershed area relationship for the upper Tombigbee River Basin

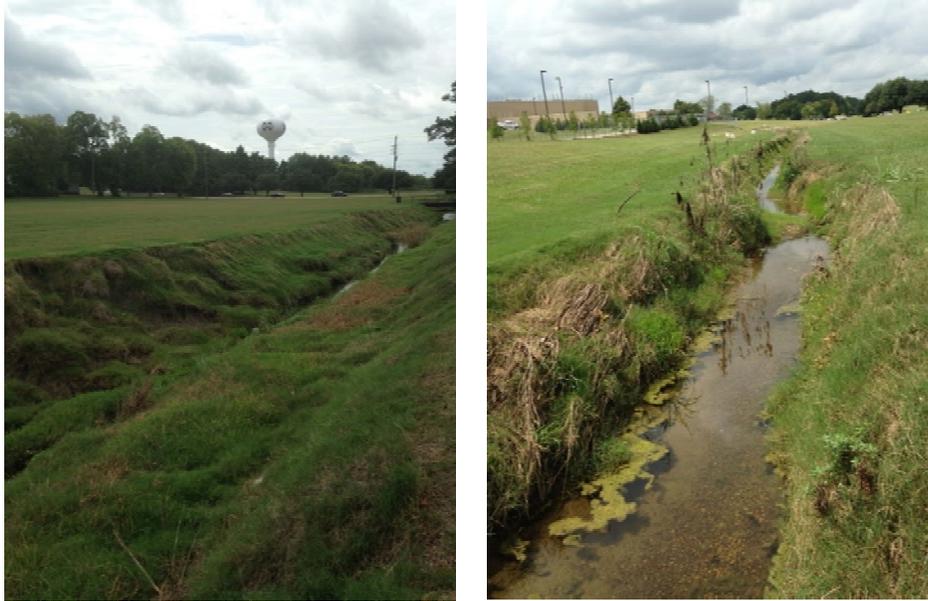
Figure 6 | Headwater tributaries of the Red Bud – Catalpa Creek Watershed.

Small tributaries at the upper part of the watershed are stable grassed channels that present some backwater flow and floodplain flooding during high stormflow events caused by the presence of downstream hydraulic structures (i.e. culverts and dams). However, these streams appear to present an early stage of incision probably due to their very low sinuosity and the increase in extension of developed areas on the MSU campus, which reduce the time of concentration and increase the magnitude of the peak flow discharges during stormflow events that usually occur during the winter and spring seasons, most commonly, when the groundcover of the streambanks is reduced.

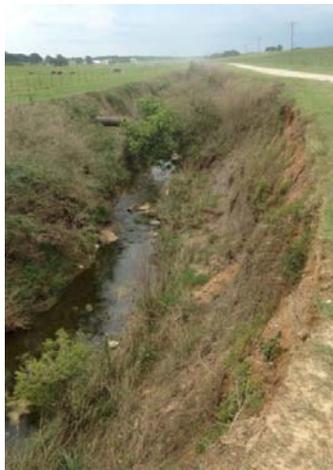
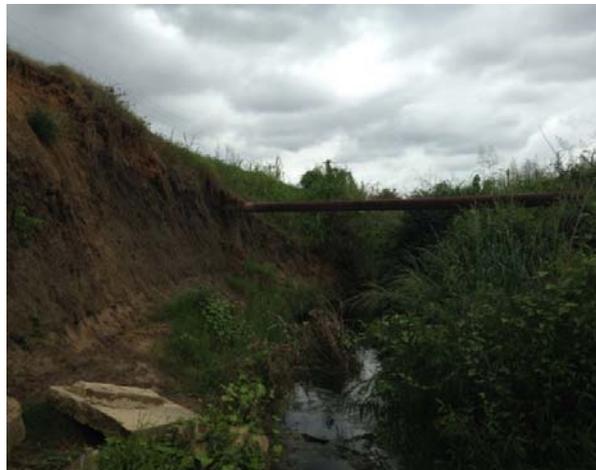
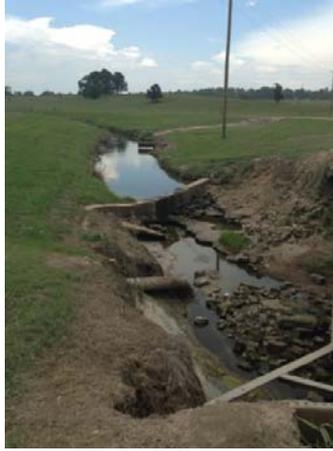
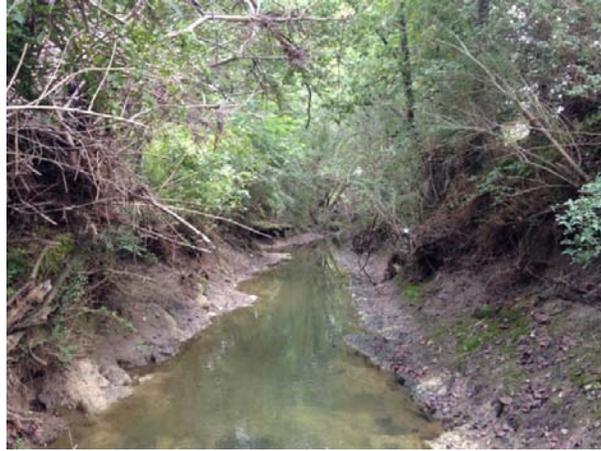
Figure 7 | Evidence of low sinuosity, active unstable streambanks, undercutting and streambed erosion/outcrop along the main stream and below a hydraulic structure in a tributary of the Red Bud – Catalpa Creek Watershed.

The incised main channel of the Catalpa Creek experiences undercutting, streambed outcrop, and streambank instability along several segments of the approximated four miles this waterbody runs through the MSU HH Leveck facility. These channel degradation processes alternate with the presence of sand and gravel bars observed a few feet upstream of road crossings and stream junctions, and inside of bendway segments. A culvert on the main stream at the boundary of the MSU campus appears to be an initial knickpoint that has affected the flow regime and sediment transport capacity of the fluvial system downstream. These conditions, in addition to the high flows coming from the campus during stormflow events, the very low sinuosity of the channel, the presence of a hydraulic structure (dam) in a tributary, additional road crossings along the main stream, and several point source flows (i.e. pipes) appear to be increasing the channel slope, and increasing undercutting, streambed erosion and incision, and streambank failure of the main stream and tributaries. Accessibility to the streams is very limited and unstable active streambanks are easily identified. Rates of streambank erosion are not reported for Catalpa Creek or its tributaries, but studies in the Ecoregion 65 in Mississippi have reported widening rates of up to 2.7 m per year (Ramirez-Avila, 2011, Simon *et al.*, 2002). At the southern boundary of the HH Leveck facility, the stream maintains its incised conditions, but an increase in its sinuosity is evidenced by the most common presence of segments with sequential patterns of rills and pools, and a reduction in the channel slope and the streambank sides' slopes. Undercutting and active unstable streambanks are observed, but their frequency along the watercourse is reduced.

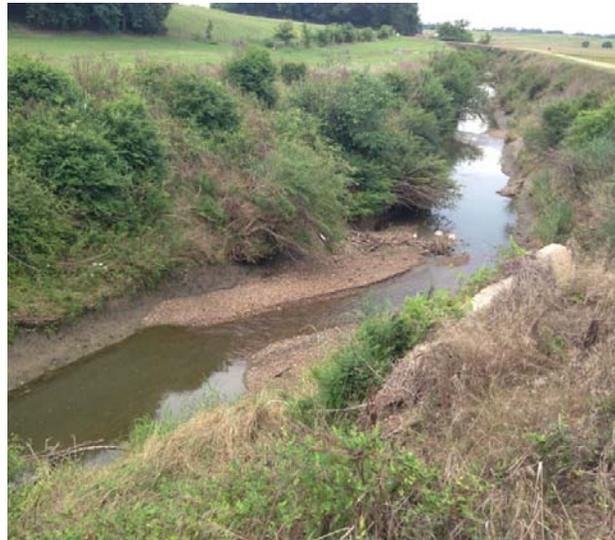
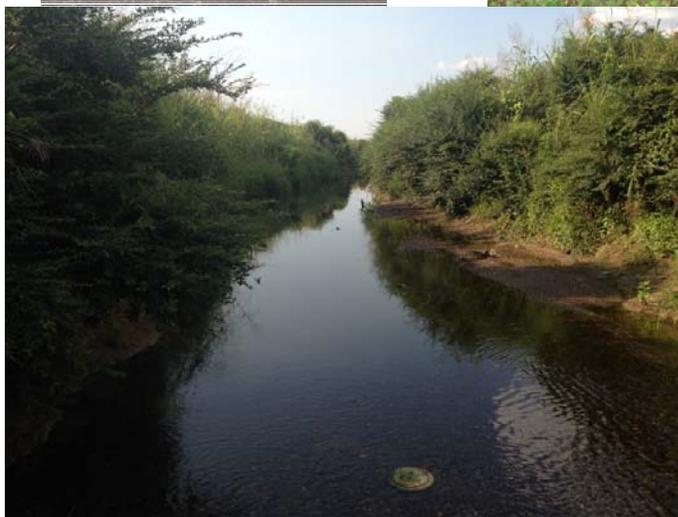
Figure 8 | Sand and gravel bars formation along internal sides of bendways, upstream of streams junction and stream segments with abundant vegetation along the main stream of the Red Bud – Catalpa Creek Watershed (left). Riffles and pool segment in a meandering section along the Red Bud – Catalpa Creek Watershed (right).

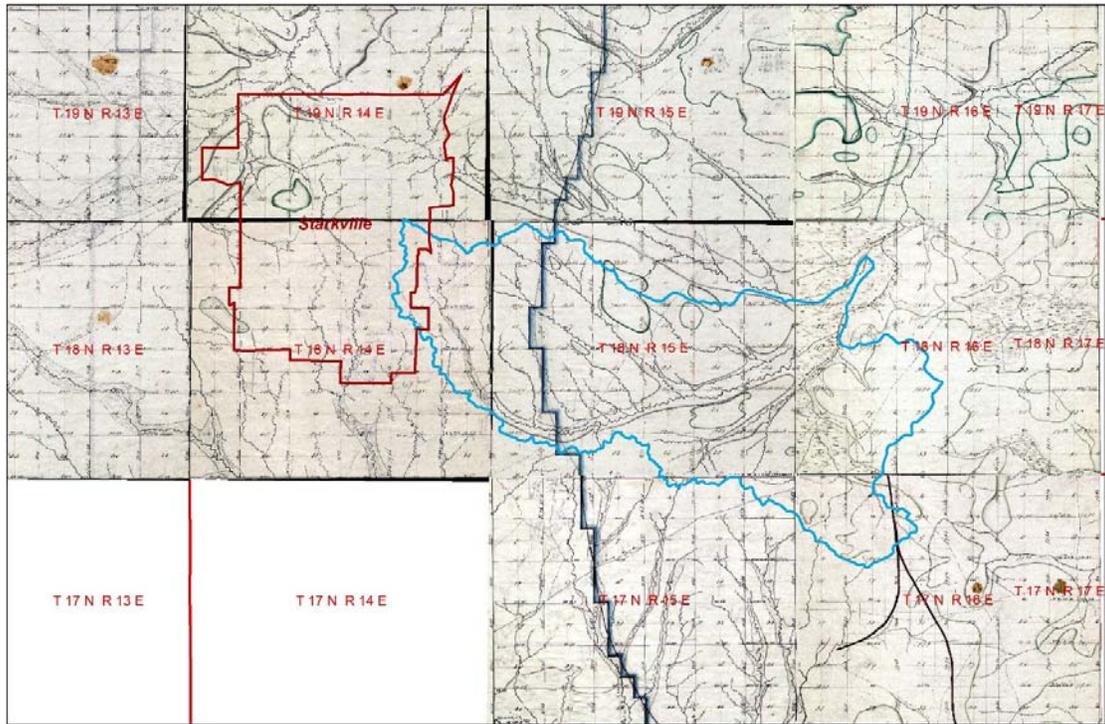
Figure 9 | 1832 General Land Office (GLO) plat maps associated with the Catalpa Creek Watershed. The watershed boundary is shown in blue. Also seen are boundaries of the historic floodplain, tributary streams, and prairies.

A comprehensive early description of the plant communities of the watershed comes from the original surveys of the General Land Office in the 1830s (Figure 9). These surveys laid out townships and described the potential productivity of the natural resources seen along the section lines. The section descriptions were aggregated into township plat maps showing river courses and floodplains, tributary streams, and in the case of Northeast Mississippi, the location of prairie openings within the forest that generally dominated the landscape. Five of these prairies were described nearest the northern ridge/boundary of the watershed, the largest being approximately one square mile (640 acres) in size.

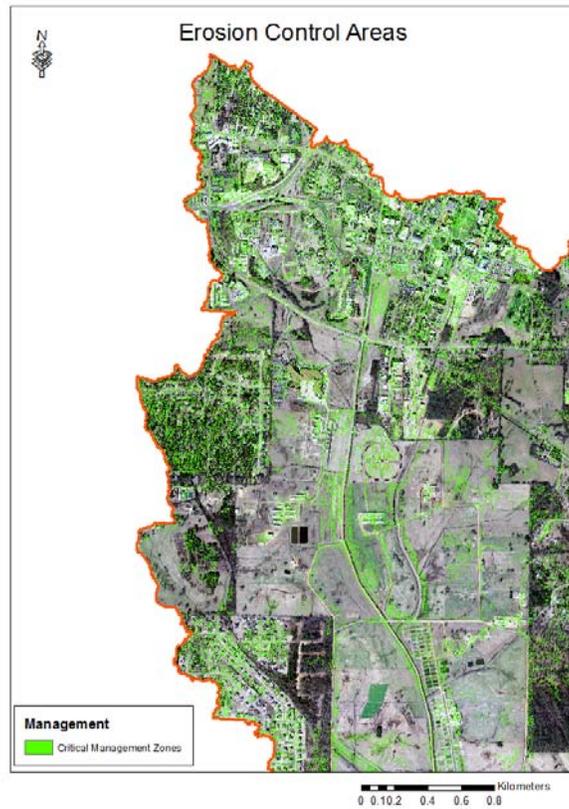
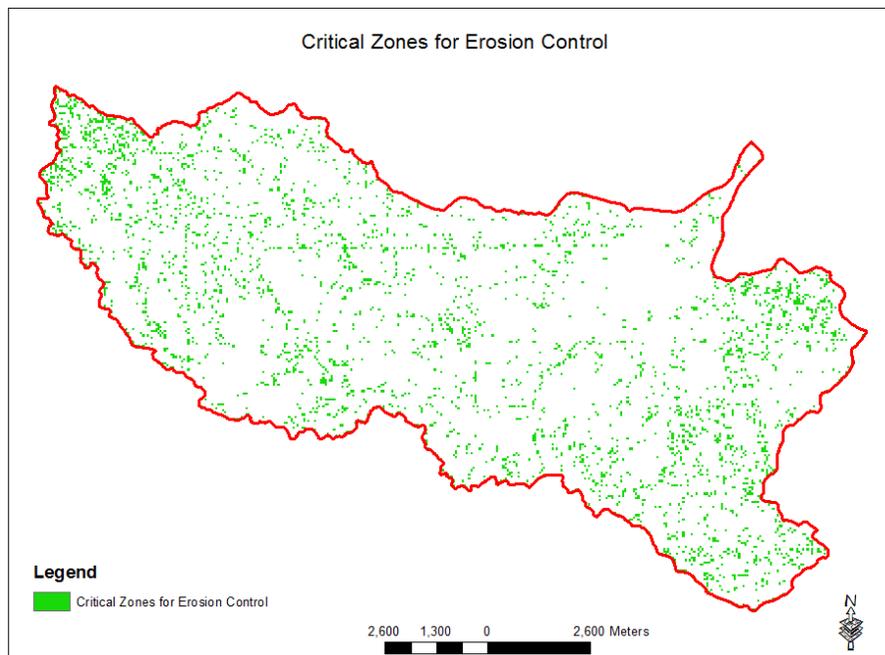
Figure 10 | Critical Management Zones for Erosion Control within the Catalpa Creek Watershed.

Critical management zones for erosion control were determined by identifying areas with annual soil losses higher than the soil loss tolerance for the corresponding map unit. From the 11,700 ha in the watershed, approximately 7.6% of the area (890 ha) was included within the critical management zones for erosion control. Around 265 ha correspond to areas under cultivated crops, 175 ha to areas under pastures/hay, 131 ha to shrub/scrub lands, and other 133 ha to developed areas and unpaved roads.

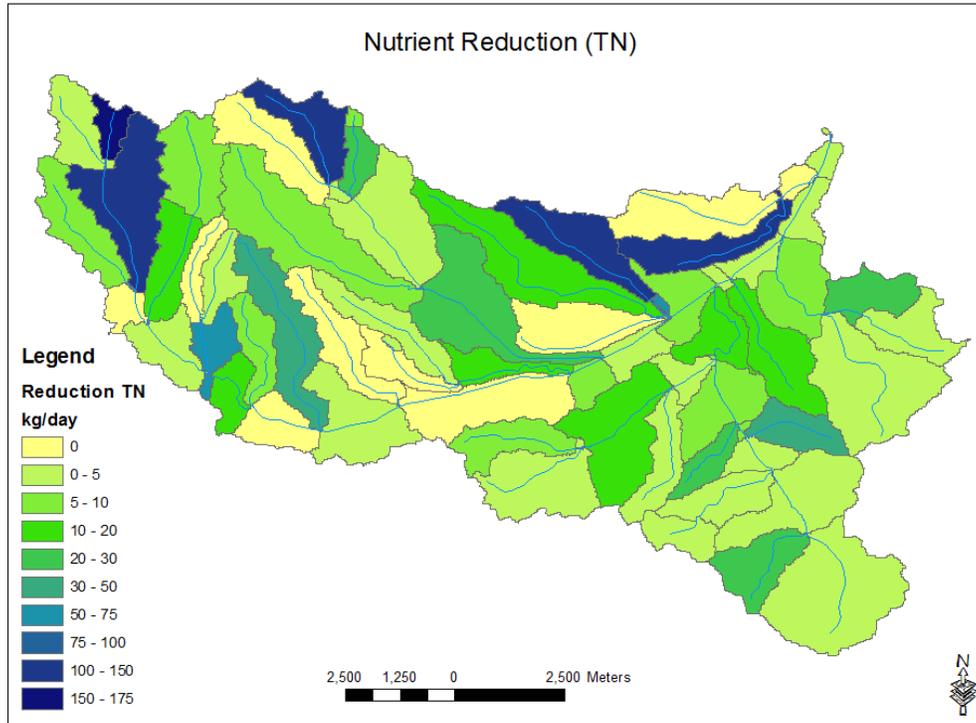
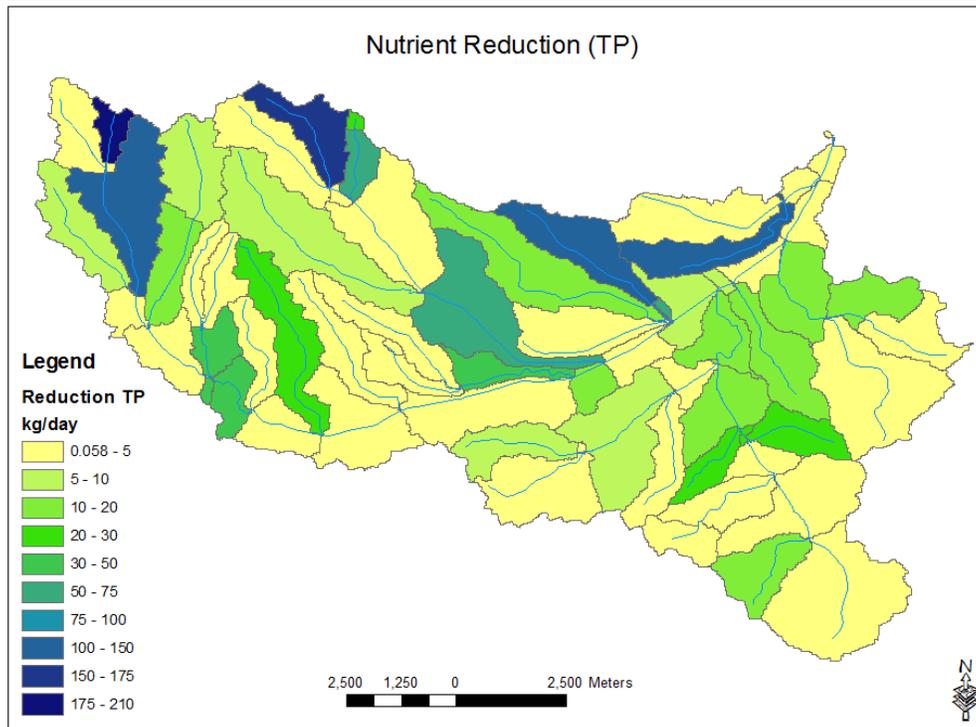
Figure 11 | Total Nitrogen and Total Phosphorus Load Reduction (kg/day) within the Catalpa Creek Watershed.

A total of 1,100 ha along the northern headwaters, out of the entire watershed area, especially those areas including the MSU Campus and the research farm, are part of the critical management zones with most important contribution of nutrients (both, P and N) and highest rates of reduction needed to achieve the proposed targets. The most critical area is mostly urban (MSU Campus), as the other sub watersheds have very mixed land uses, but with a predominance of pasture/hay systems.
